Your Inspection Report

27 Maple Crescent
Toronto, ON

RE: Report No. 1366, v.7
27 Maple Crescent
Toronto, ON

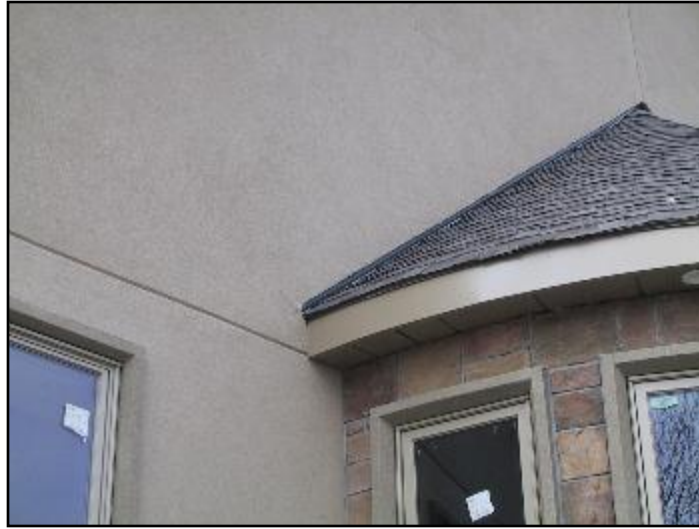
Condition: • [No kickout flashing](#)

Implication(s): Chance of water damage to contents, finishes and/or structure

1. No kickout flashing at roof/sidewall junction

Task: Improve

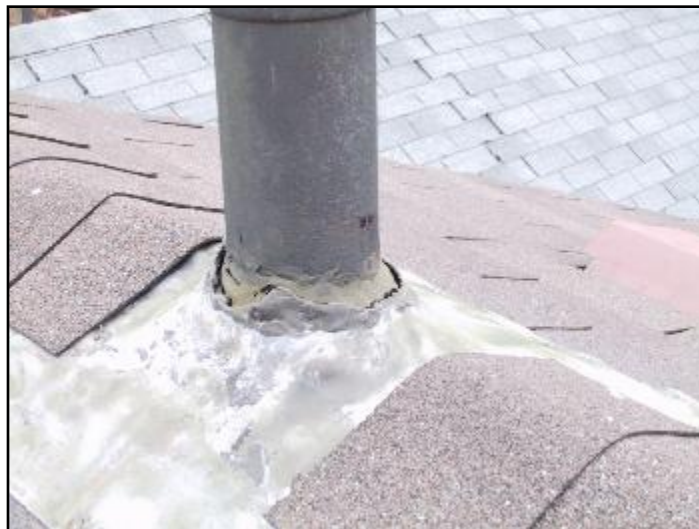
Condition: • [Leak](#)

Implication(s): Chance of water damage to contents, finishes and/or structure

2. Stack flashing should be sealed.

Task: Repair

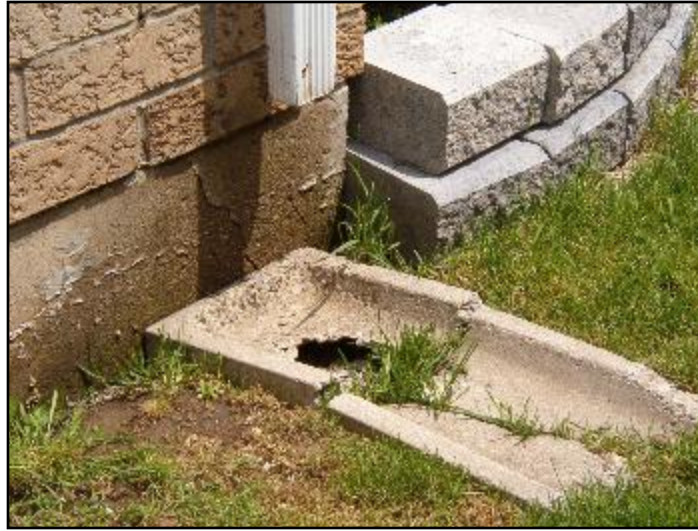
Condition: • [Downspouts end too close to building](#)

Implication(s): Chance of water damage to contents, finishes and/or structure

3. *Downspout should be extended away from home*

Note: The downspout should be extended to discharge at least 6 feet from the home. The broken splash block can be discarded.

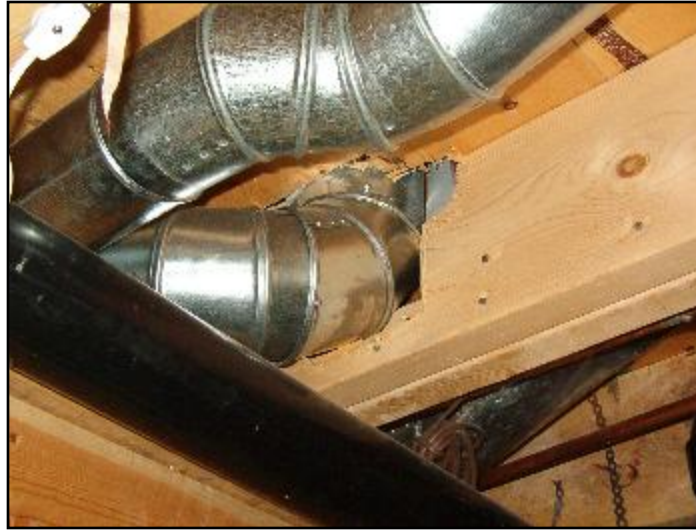
- Condition:** • [Notches or holes](#)
- Implication(s):** Weakened structure
- Location:** West Basement
- Task:** Repair
- Time:** Immediate

4. Double joist cut for ductwork

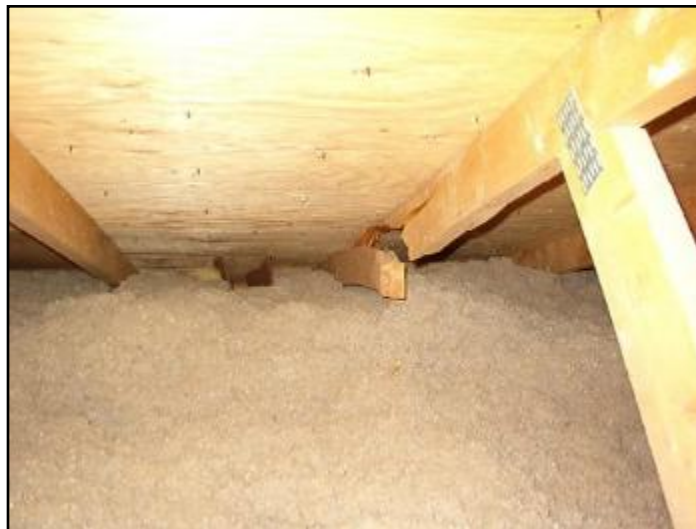
Condition: • [Split](#)

Implication(s): Weakened structure | Chance of structural movement

5. Top chord of truss is broken

Task: Repair or replace

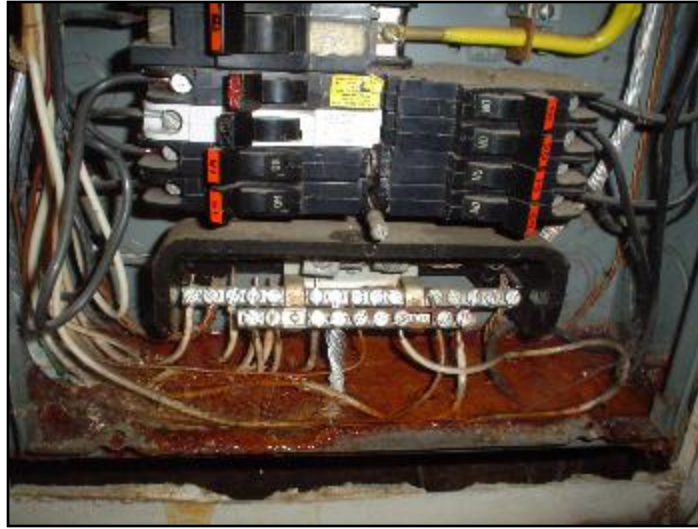
Condition: • [Rust or water in panel](#)

Implication(s): Electric shock | Fire hazard

6. Water and rust in bottom of panel

Task: Replace

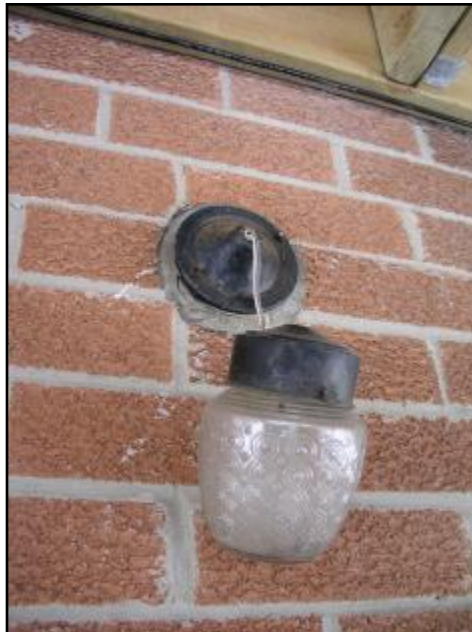
Condition: • [Loose](#)

Implication(s): Electric shock | Fire hazard

7. Light fixture is not well secured

Task: Repair or replace

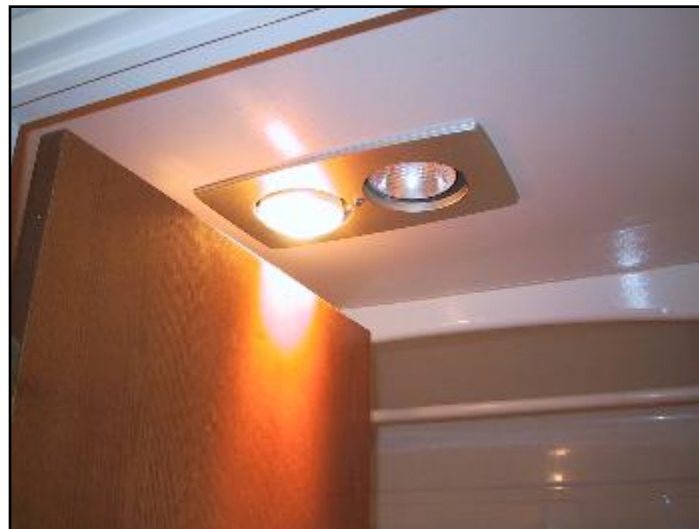
Condition: • [Heat lamps over doors](#)

Implication(s): Fire hazard

8. Heat lamp over door - fire hazard!

Task: Correct

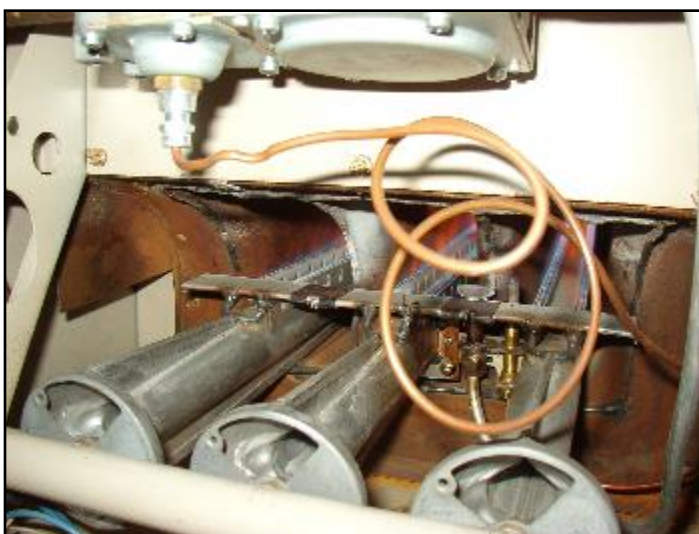
9. Rust at bottom of heat exchanger

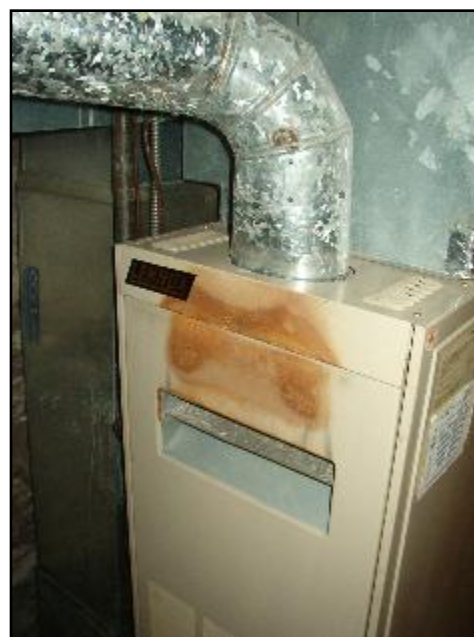
Condition: • [Draft hood spillage or backdraft](#)

Implication(s): Equipment not operating properly | Hazardous combustion products entering home

10. Evidence of furnace backdrafting

Task: Correct

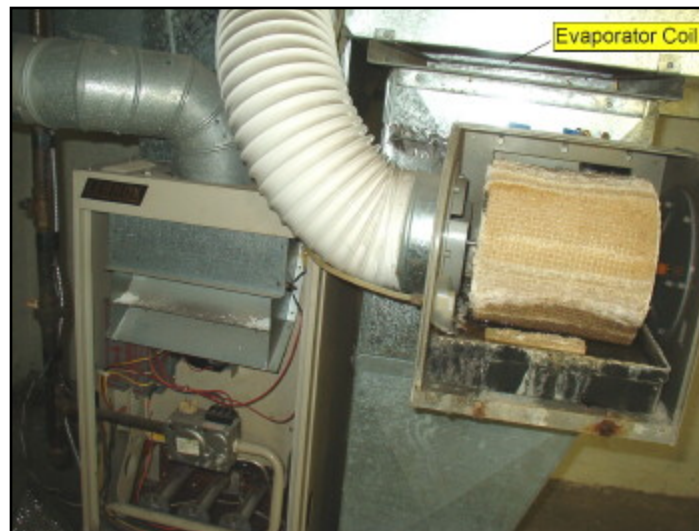
Condition: • [Leak](#)

Implication(s): Chance of water damage to contents, finishes and/or structure | Damage to equipment

11. Leaking and inoperative humidifier

Task: Repair or replace

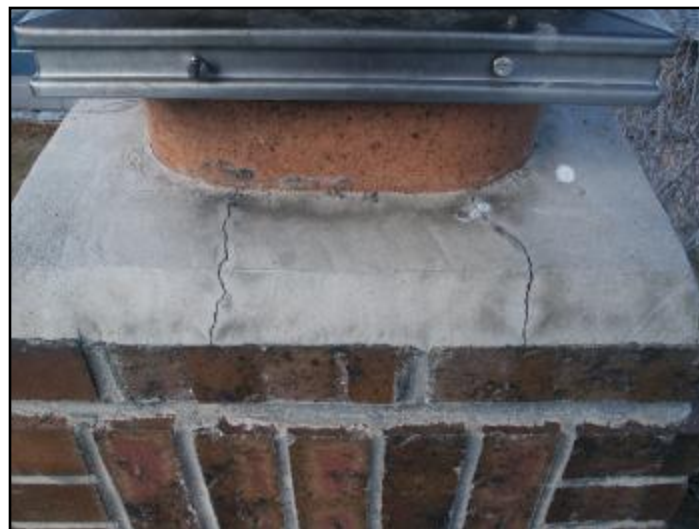
Condition: • [Cracked](#)

Implication(s): Chance of water damage to contents, finishes and/or structure | Shortened life expectancy of material

12. Minor cracks in chimney cap

Task: Repair

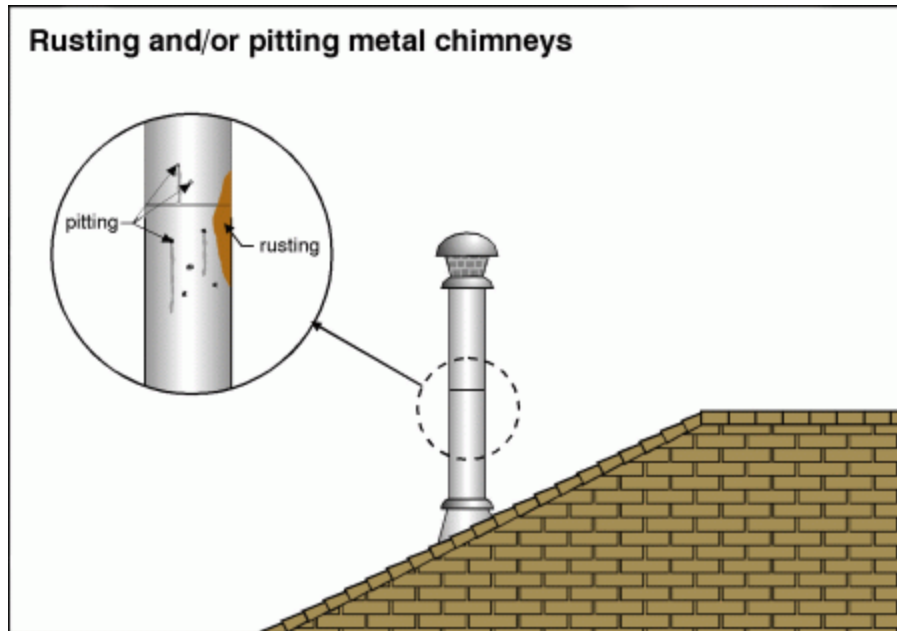
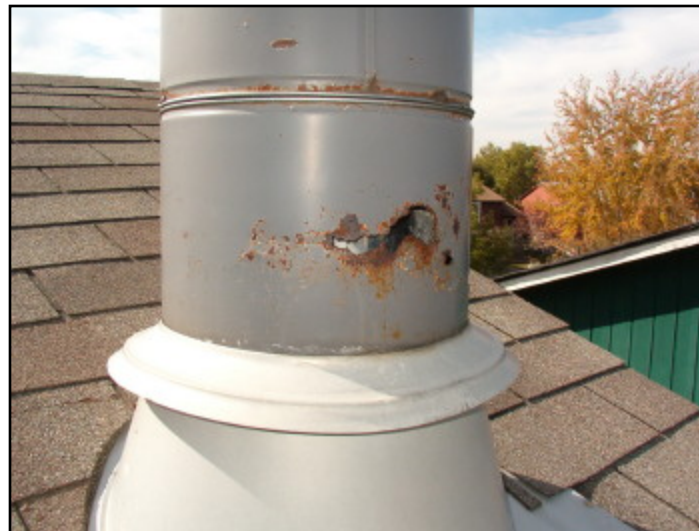
Condition: • [Chimney walls rusting or pitting](#)

Implication(s): Chance of movement | Hazardous combustion products entering home

13. Rusted chimney wall from fireplace

Task: Replace

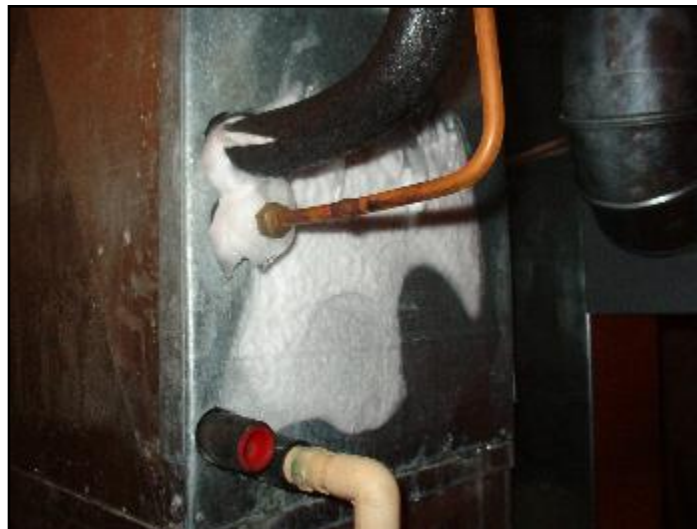
Condition: • [Frost](#)

14. Frost visible on ductwork at AC coil

Task: Repair

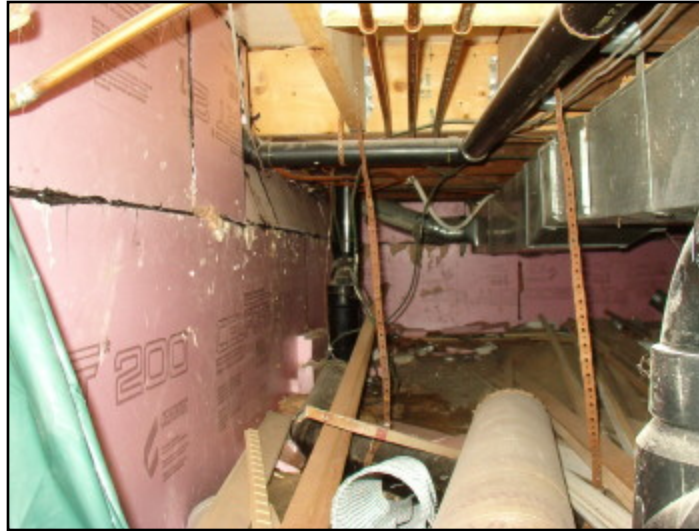
Condition: • [Exposed combustible insulation](#)

Implication(s): Fire hazard

15. Exposed polystyrene insulation is fire hazard

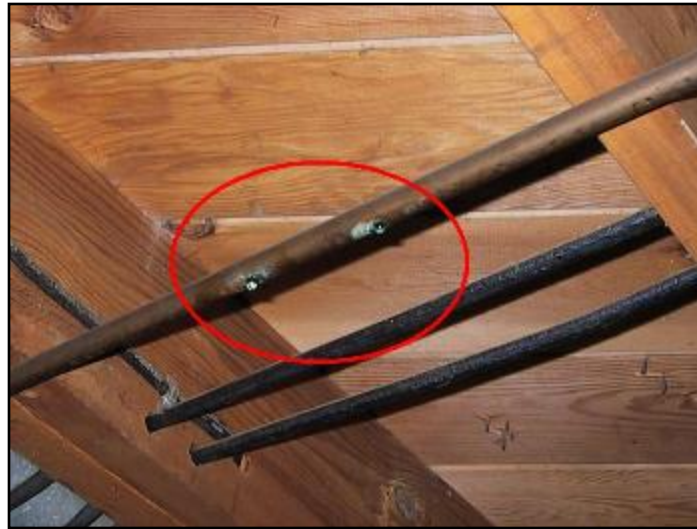
Condition: • [Leak](#)

Implication(s): Chance of water damage to contents, finishes and/or structure | System inoperative

16. Leaking copper supply pipe

Task: Repair

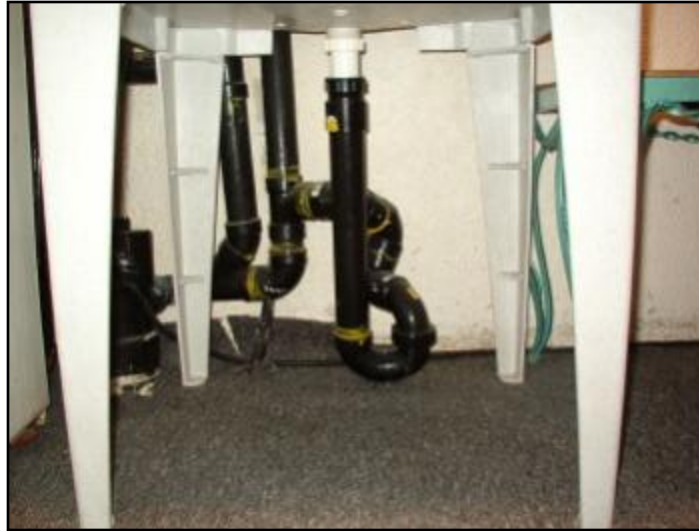
Condition: • [Nonstandard shape or material](#)

Note: This configuration is prone to clogging problems

17. Poor trap arrangement

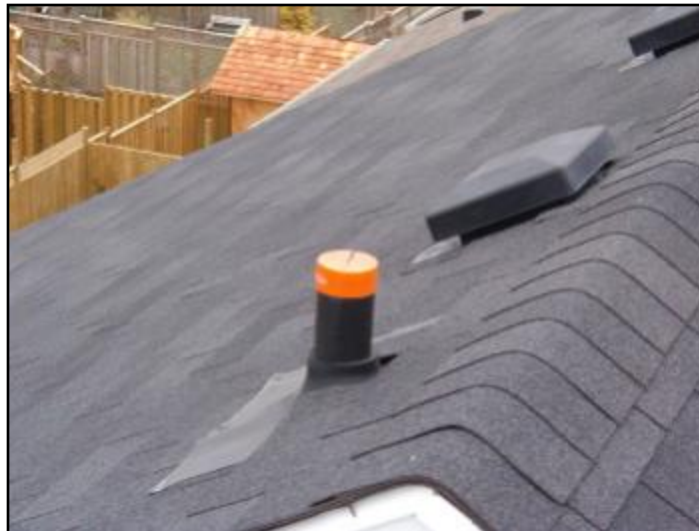
Condition: • [Vent termination problems](#)

18. Plumbing stack is capped

Task: Remove cap

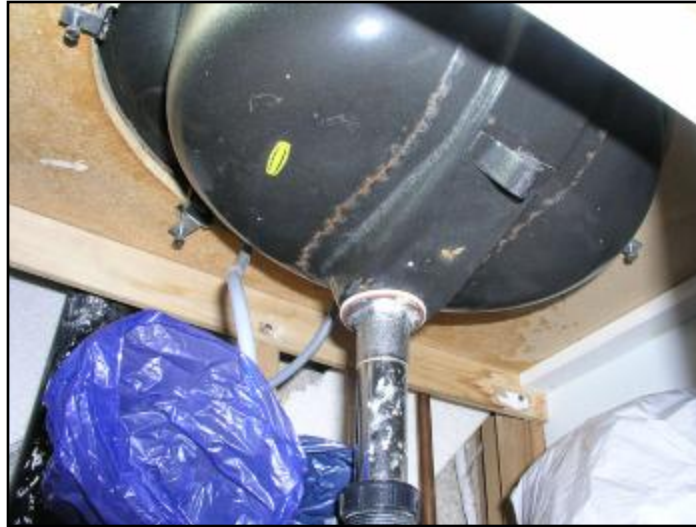
Condition: • [Rust](#)

Implication(s): Cosmetic defects | Chance of water damage to contents, finishes and/or structure

19. *Steel basin rusting at weld*

Task: Replace

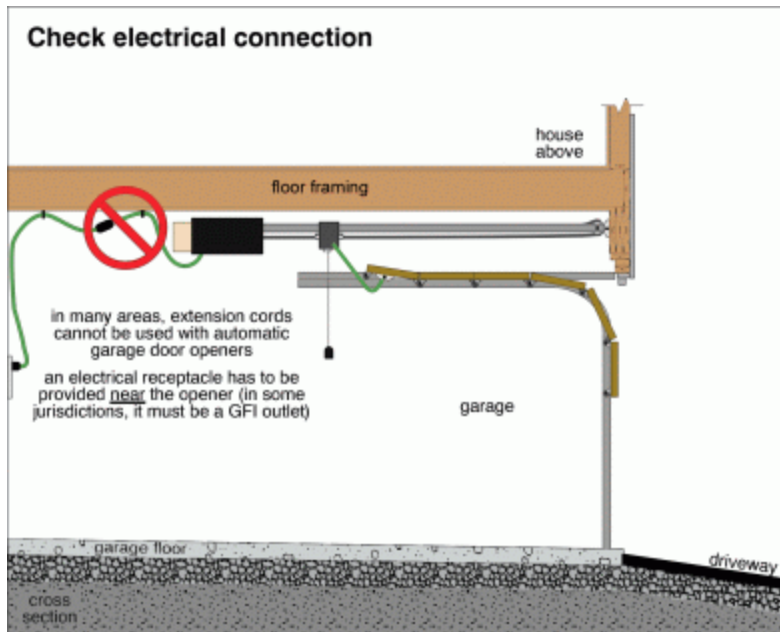
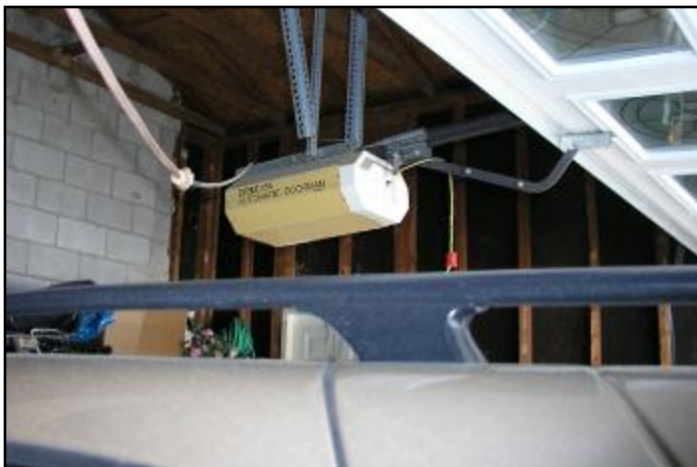
Condition: • [Extension cord for opener](#)

20. Extension cord for west garage door opener

Task: Replace with permanent wiring

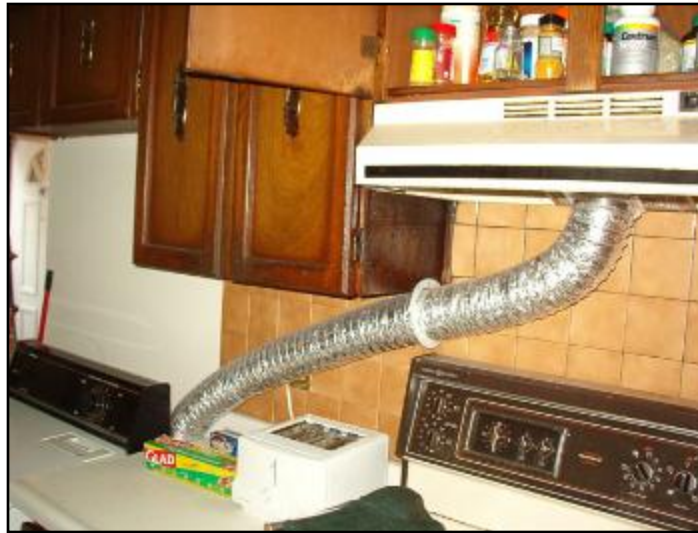
Condition: • The clothes dryer is vented into an exhaust fan designed for a stove. This unconventional installation should be re-arranged.

22. *Clothes dryer vented incorrectly*

Task: Improve
