Your Inspection Report

1127 Janet St
Picton, ON

INSPECTION DATE:
Wednesday, February 9, 2011

RE: Report No. 1581, v.3
1127 Janet St
Picton, ON

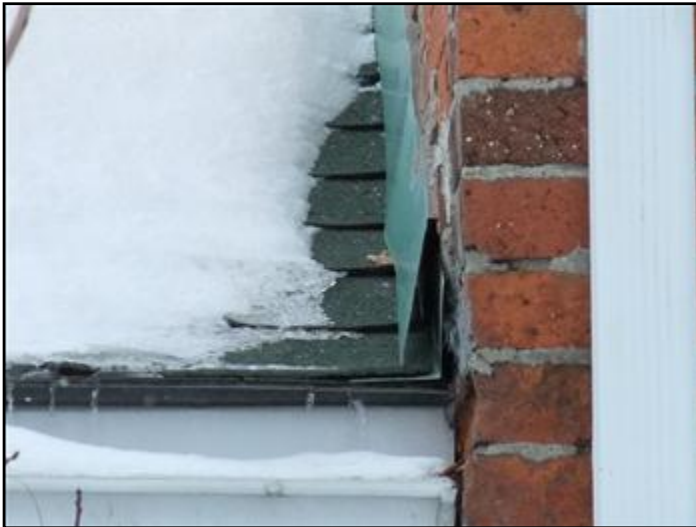
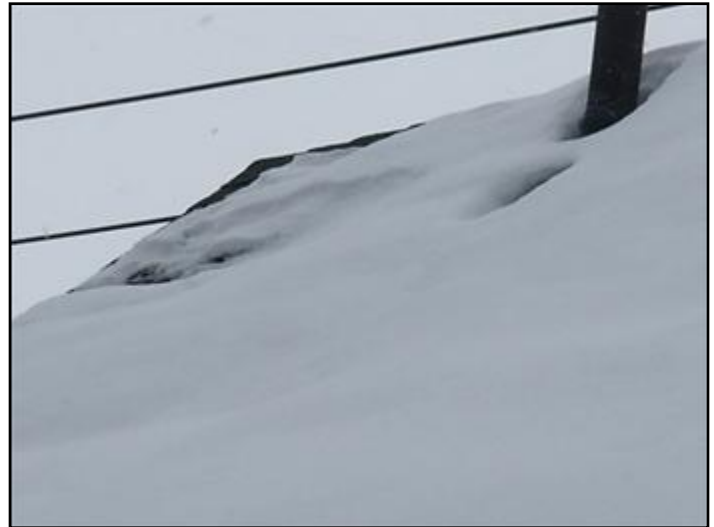
Probability of leakage: • Unable to assess age or condition of roof coverings due to heavy snow and ice cover. Some areas appear to be recently renewed, however this is based solely upon a limited view of the edge of the roofing materials where visible at the gables. It will be prudent to re-inspect the roof coverings when weather permits, to identify the age and condition of all roof surfaces, and to ensure that no defects or areas of premature wear exist.

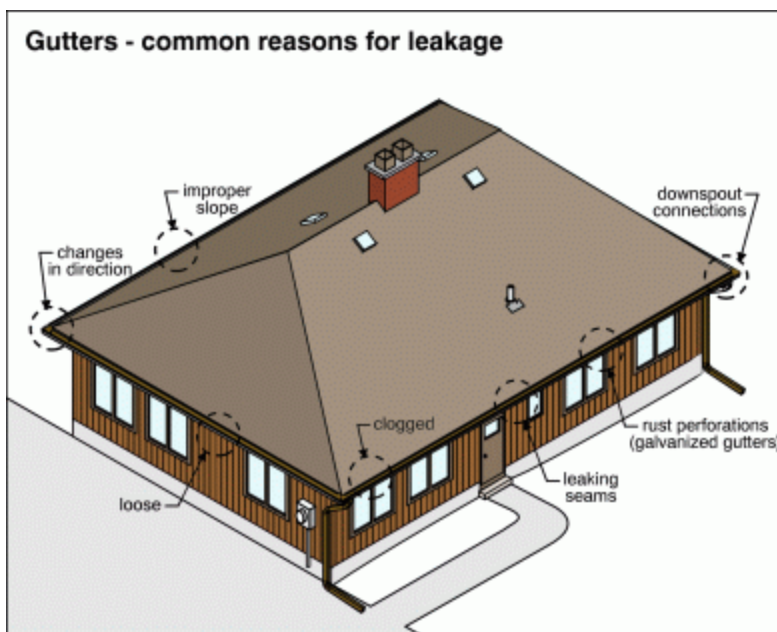
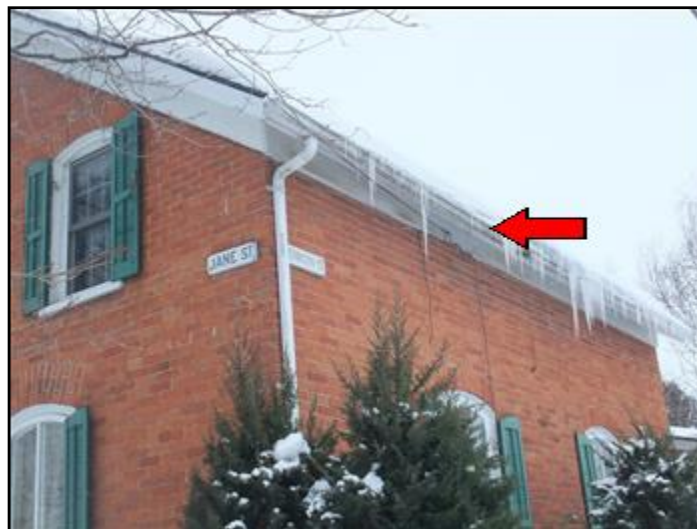
Condition: • [Improper slope, ponding](#)

Troughs are sagging under the weight of accumulated ice.

Task: Correct

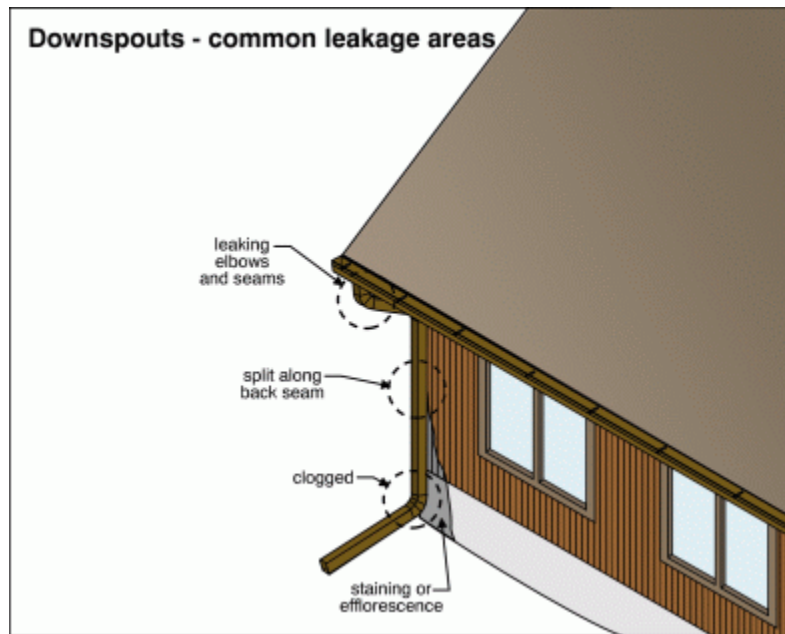
Condition: • [Clogged](#)

Task: Correct

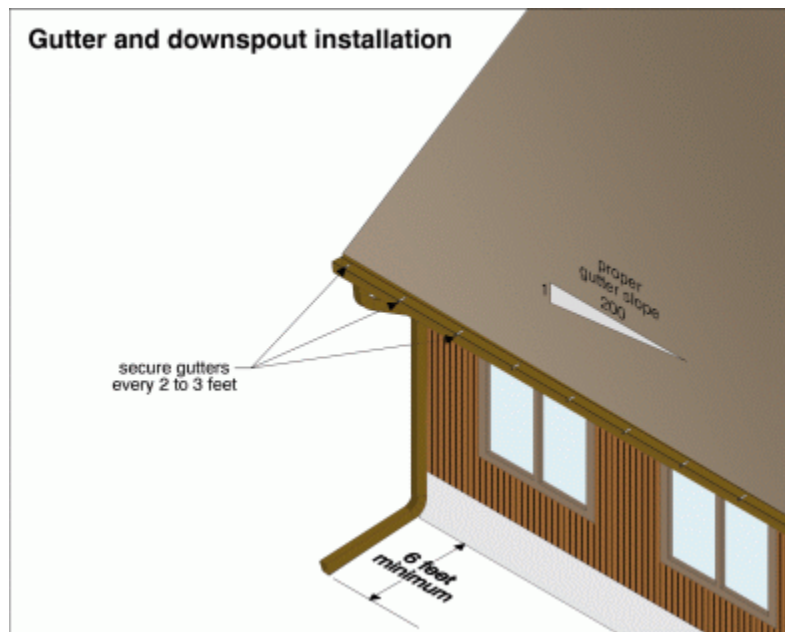
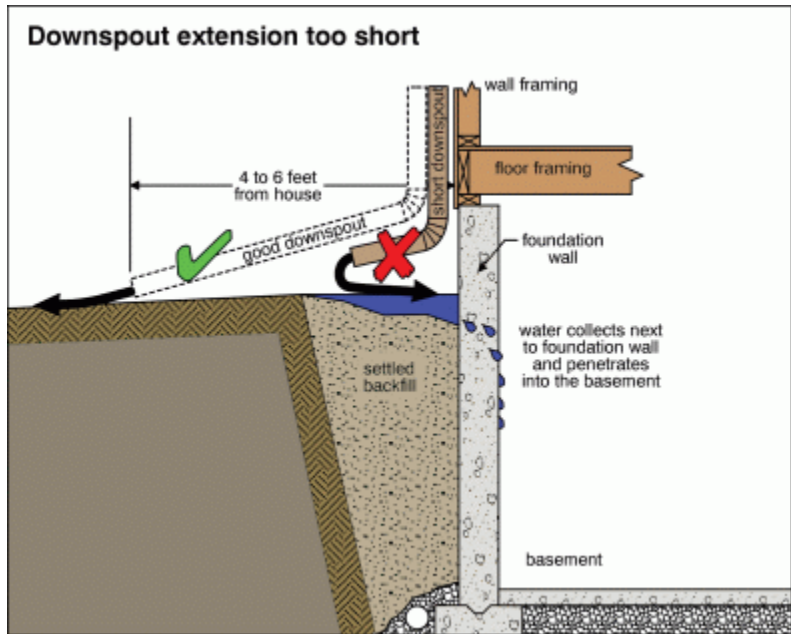
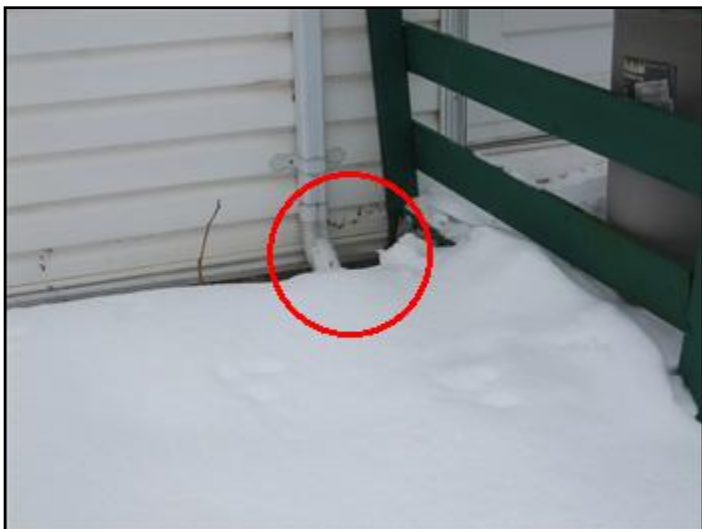
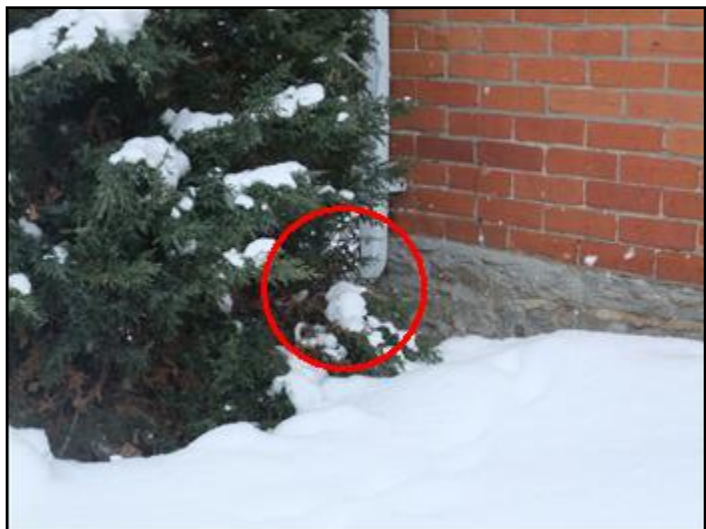
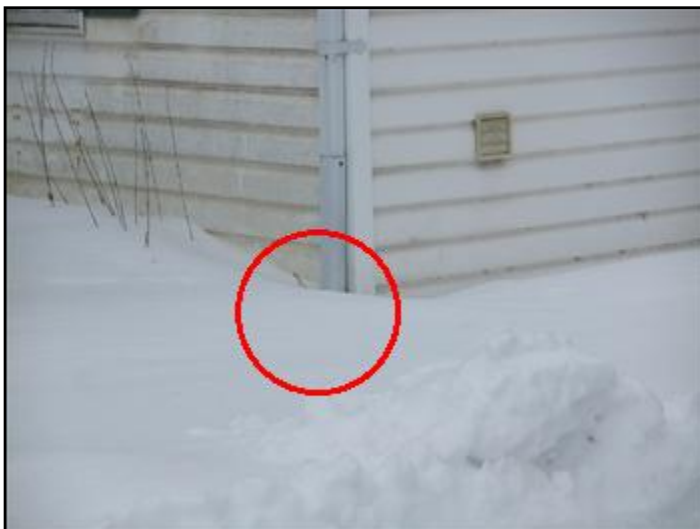
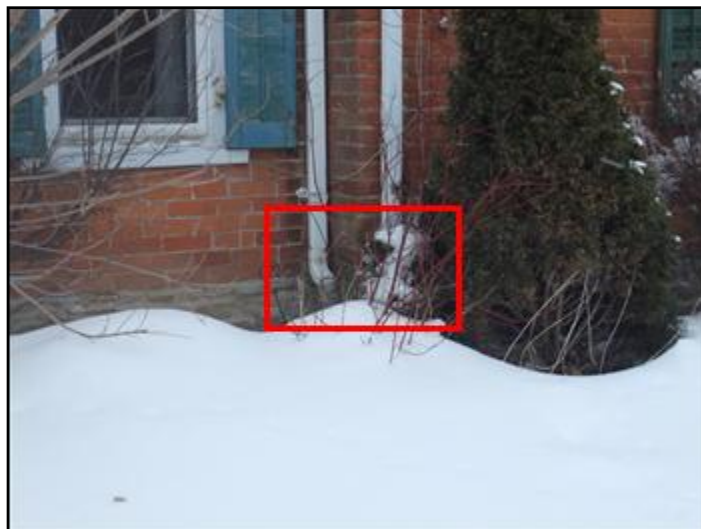
Condition: • [Downspouts end too close to building](#)

Task: Correct

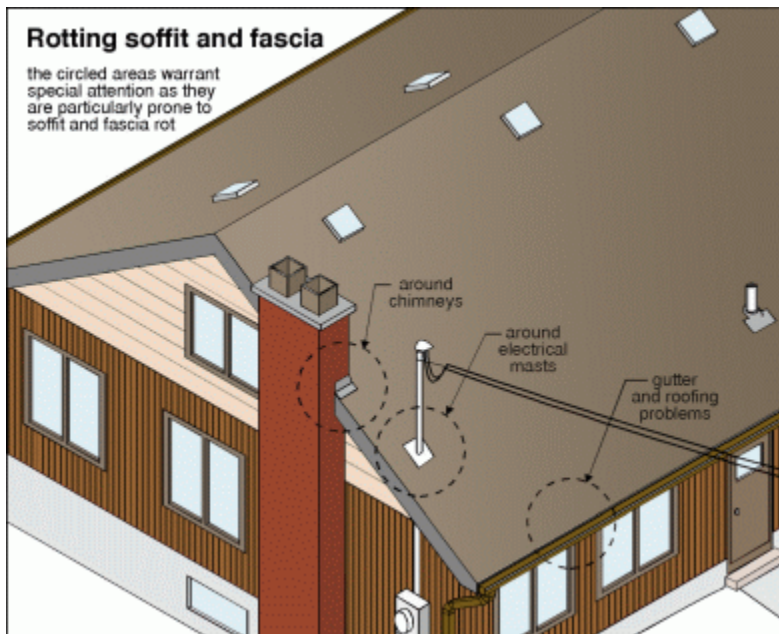
Condition: • [Paint or stain needed](#)

Task: Provide

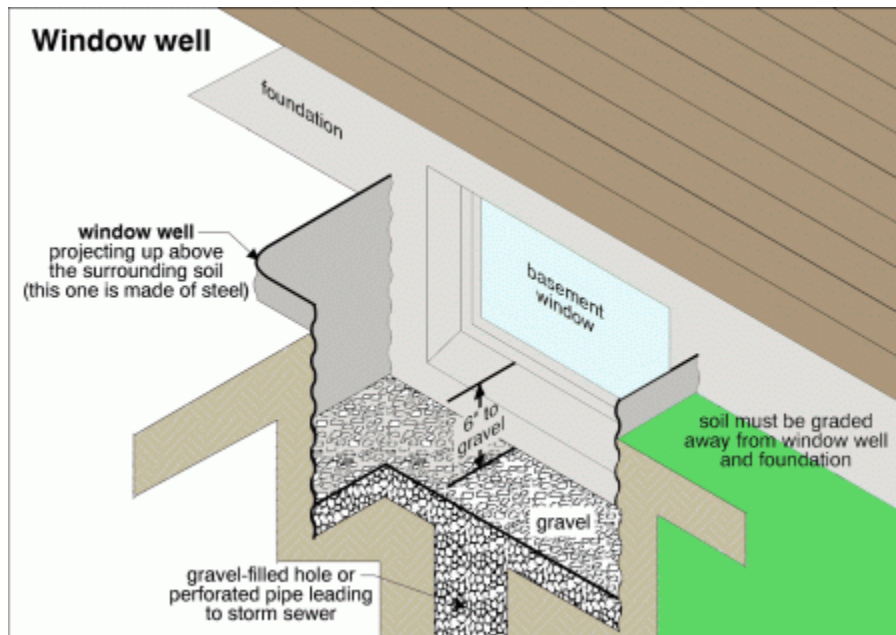
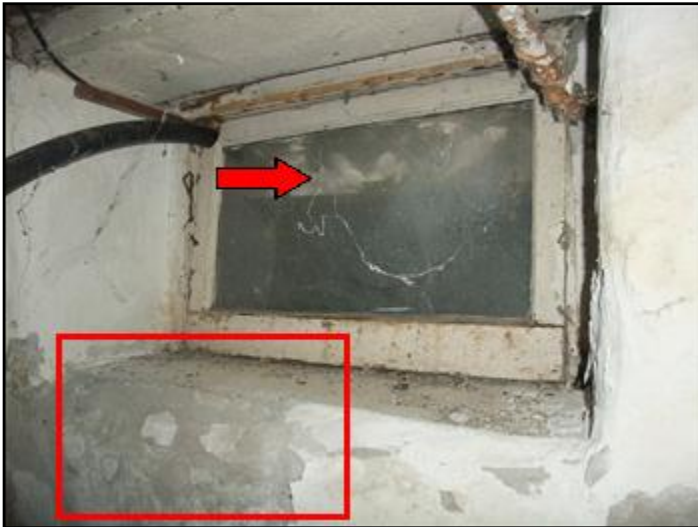
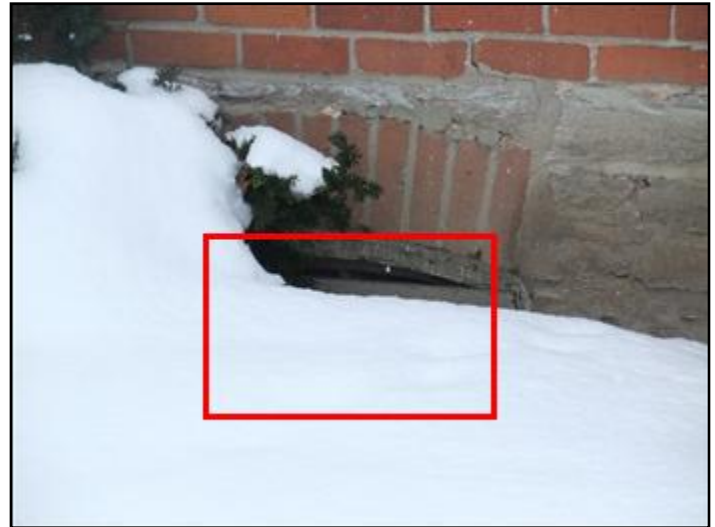
Condition: • [Missing](#)

Melting snow and storm water can drain into basement thru windows which are at, or below exterior grade.

Task: Provide

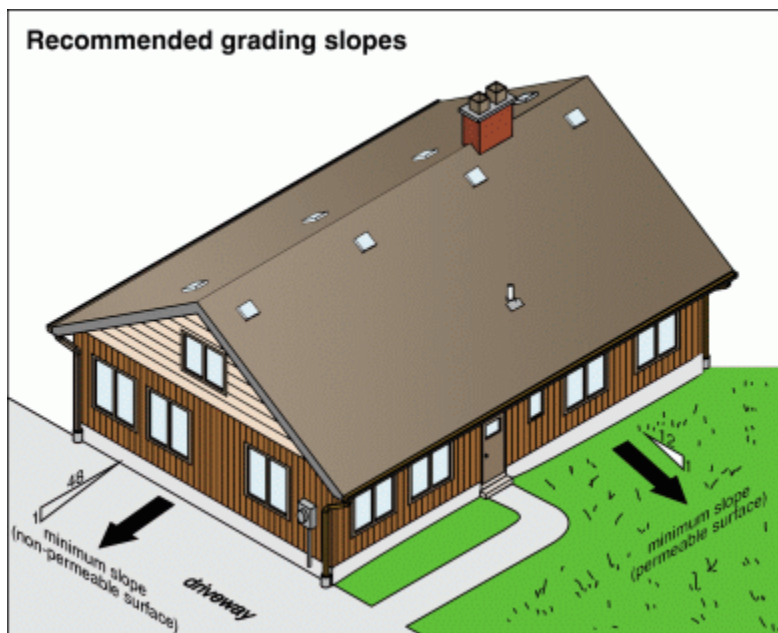
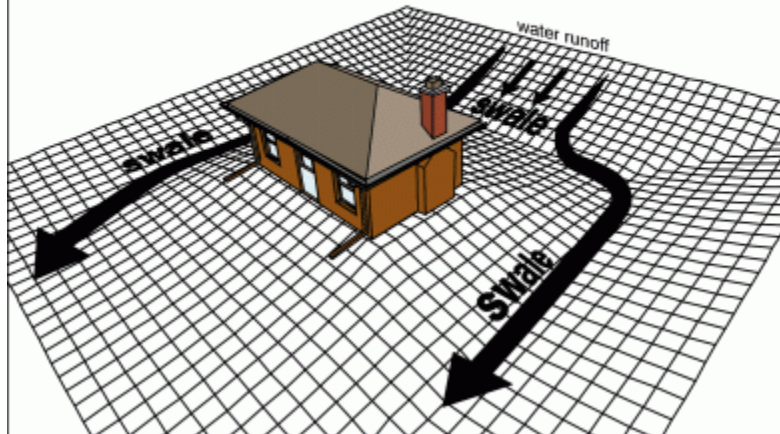
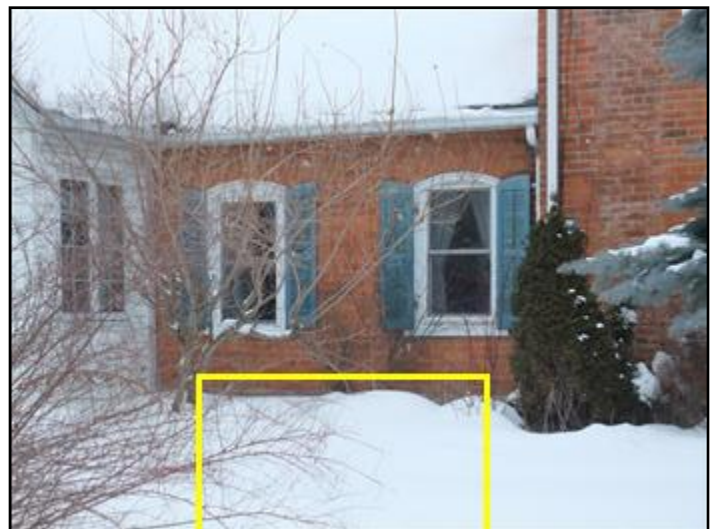
Condition: • [Improper slope](#)

Ensure that soils are properly graded away from the house, so that roof water will be dispersed away from foundations. Some areas with potential for ponding of water are indicated in the accompanying photos; other areas of interest or concern may exist.

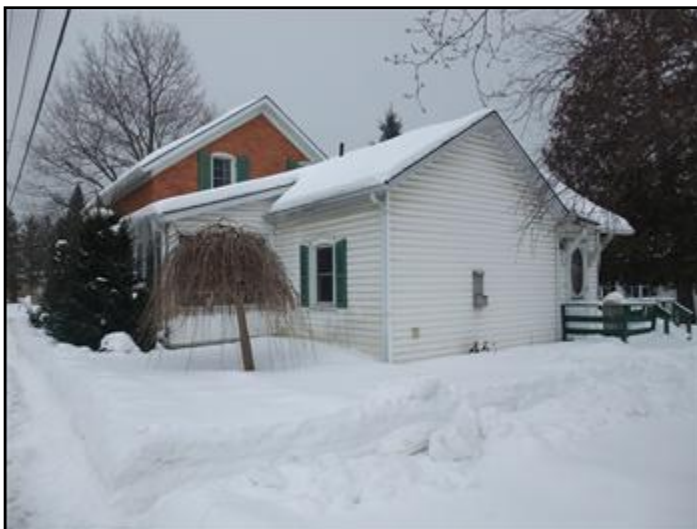
10. Some areas may be prone to ponding of water

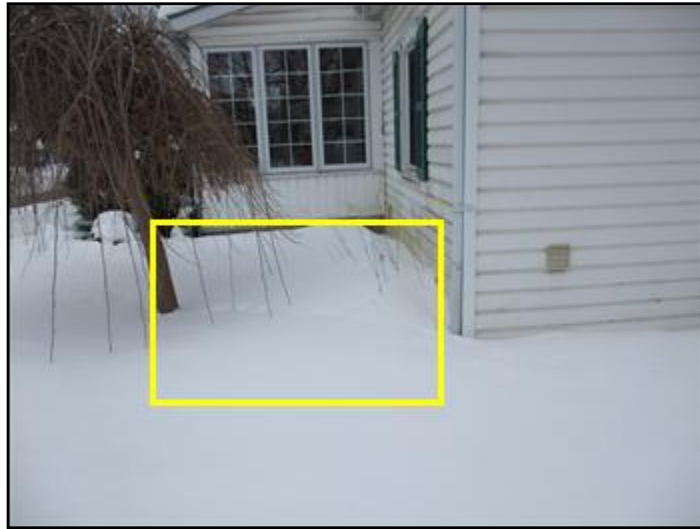
12. *Potentially poorly drained area*

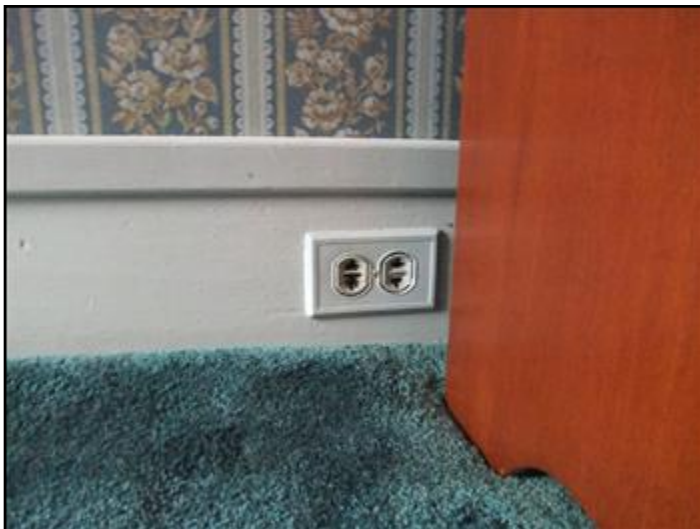
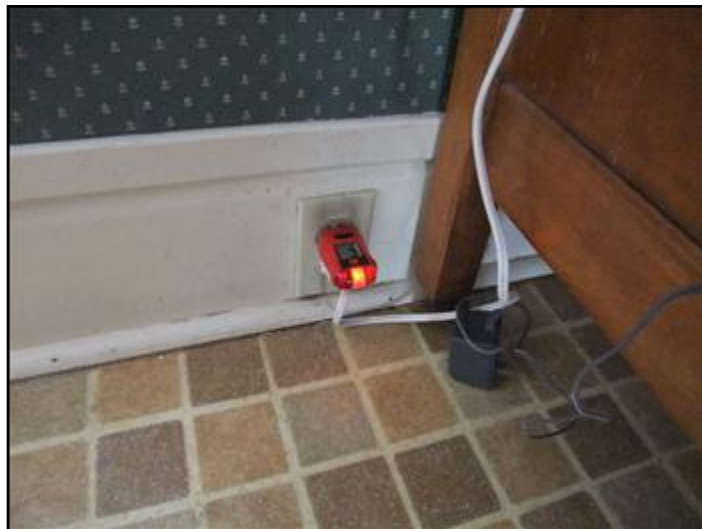
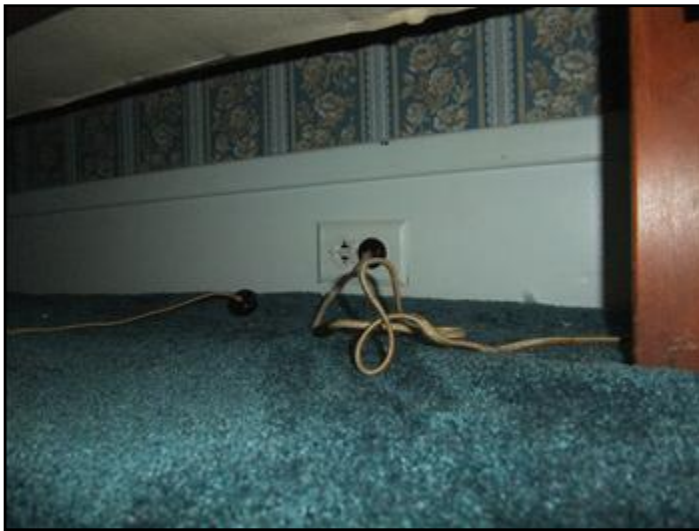
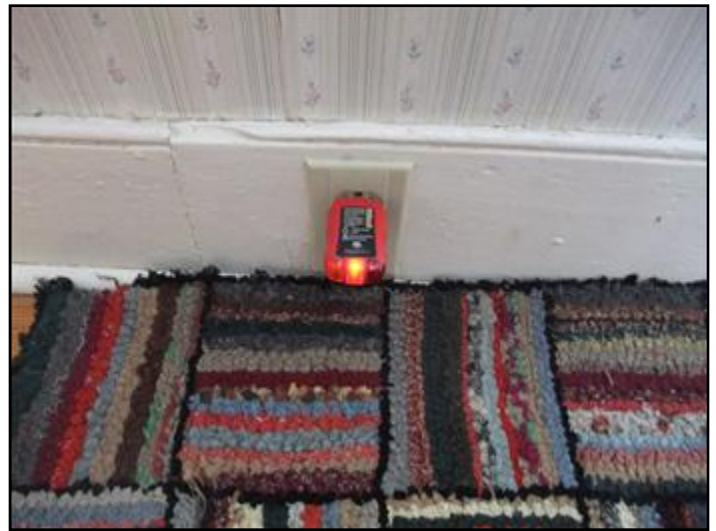
Condition: • [Ungrounded](#)

Extra grounded receptacles may be required in some areas, depending upon intended usage and occupant needs. Realize that some of the apparently grounded (three-pin) receptacles are not actually grounded. Although no vintage "knob and tube" wiring was detected during the course of this inspection, the presence of such wiring is always a possibility in older homes, especially where ungrounded receptacles are noted. The presence or absence of knob and tube wiring cannot be readily determined in the course of a one-time visual inspection such as conducted today. Consult with a licensed electrician if this is a concern.

Task: Further evaluation

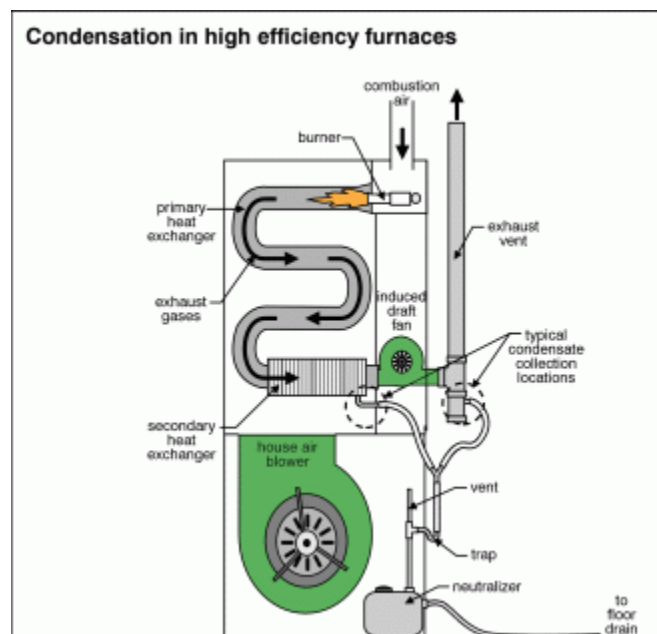
Condition: • [Condensate problems](#)

The condensate drain is leaking onto the floor, causing some rusting of the furnace cabinet, and should be corrected as soon as possible.

Task: Repair

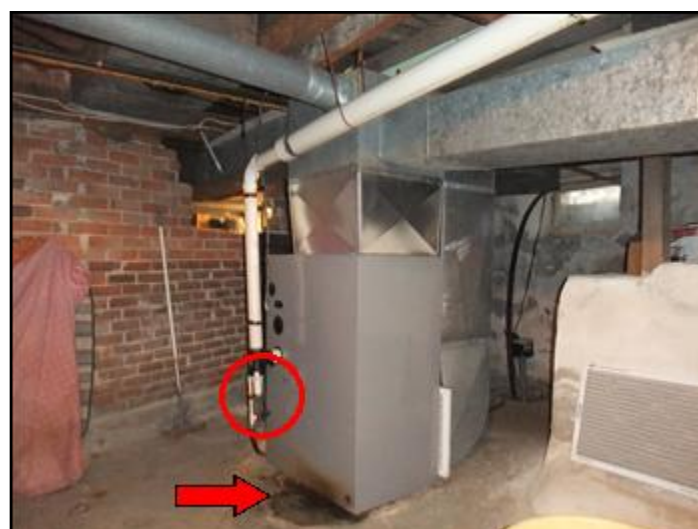
20. Leaking condensate drain

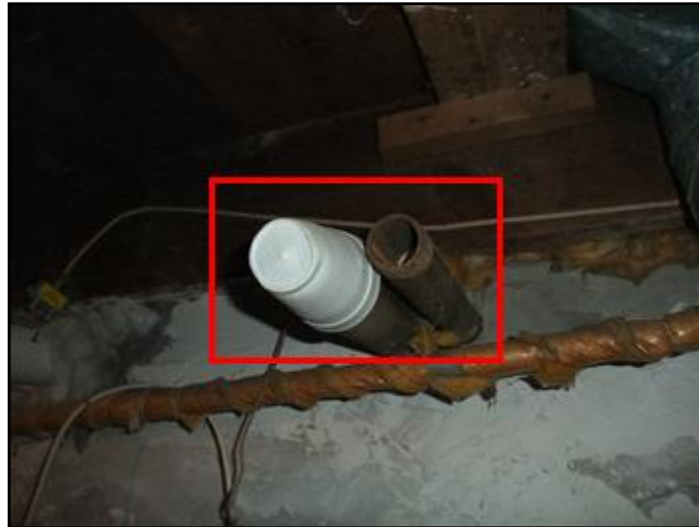
Abandoned fuel fill and vent pipes must be removed where/if they are accessible at the exterior, and prone to accidental dumping of fuel oil in the basement.

21. Abandoned fuel oil pipes

Task: Remove

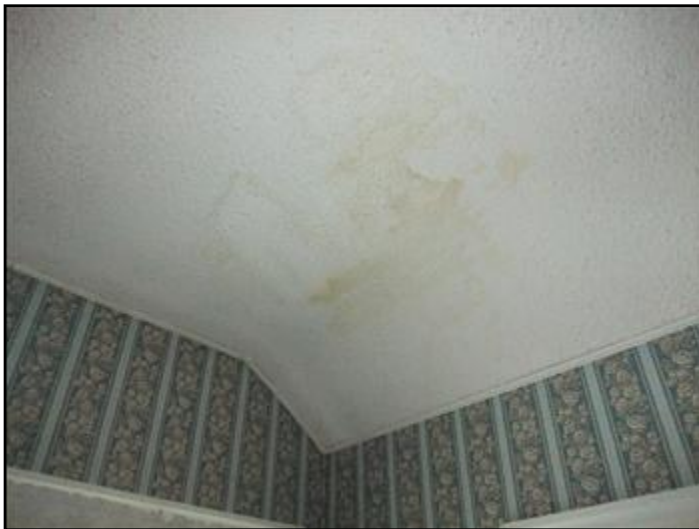
Although some of the ceiling stains may be related to the ice damming, or possibly leakage due to other causes, it is also possible that they are the result of condensation caused by air leakage into the roof spaces. Some marking may be related to paint mismatches. Cracked and loose plaster, where no stains exist, may be caused simply by age and drying.

22. *Appears to be a paint problem*

Task: Further evaluation

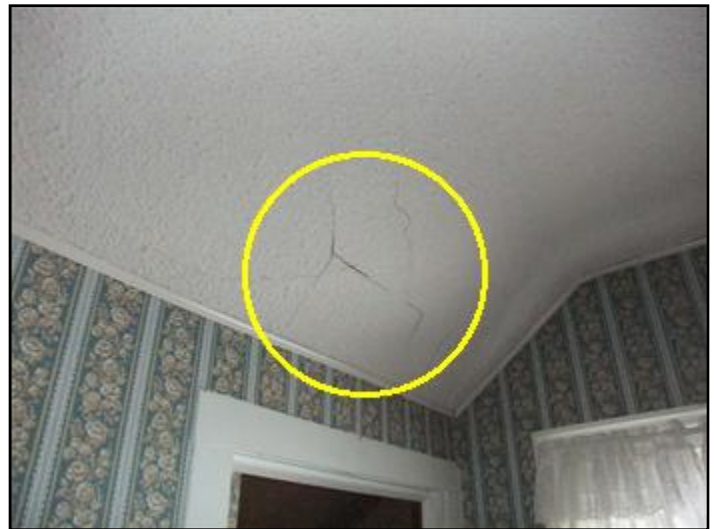
23. *Loose, cracked plaster/lath*

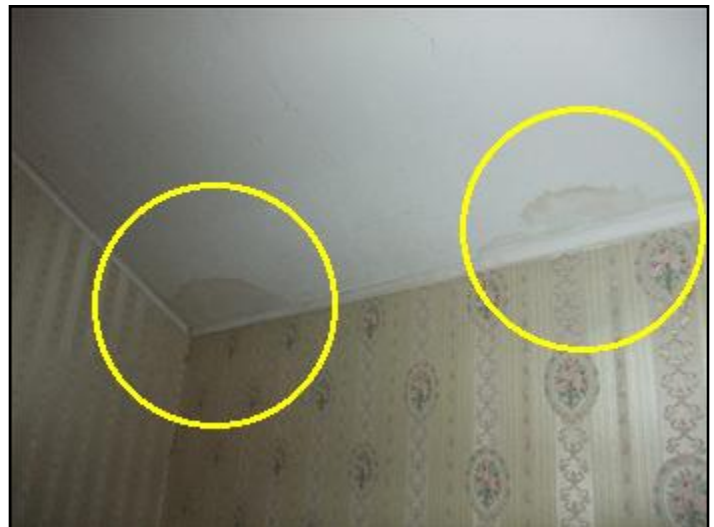
25. *Stains below eaves, possibly from ice dams*

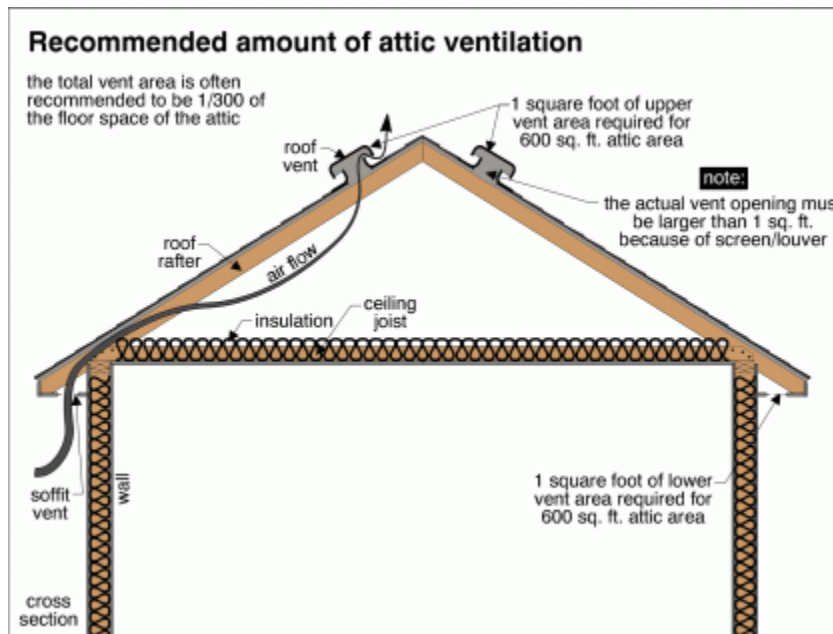
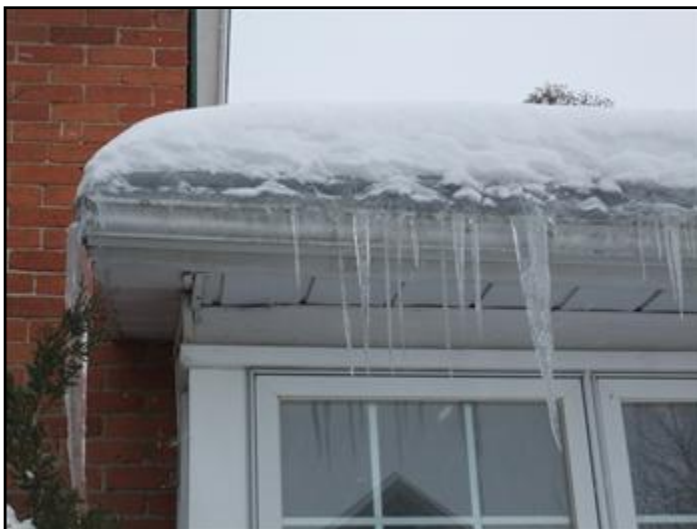
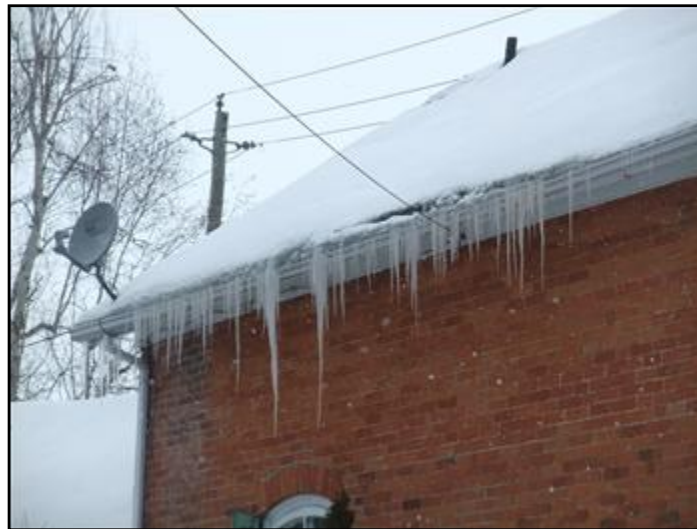
Condition: • [Inadequate](#)

The melted snow and ice dams are indicative of inadequate roof ventilation, possibly insulation as well.

Task: Improve

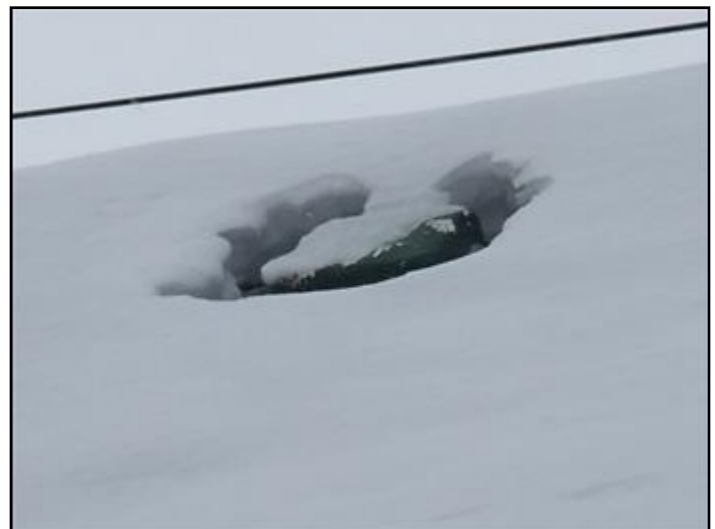
27. One only, roof vent visible

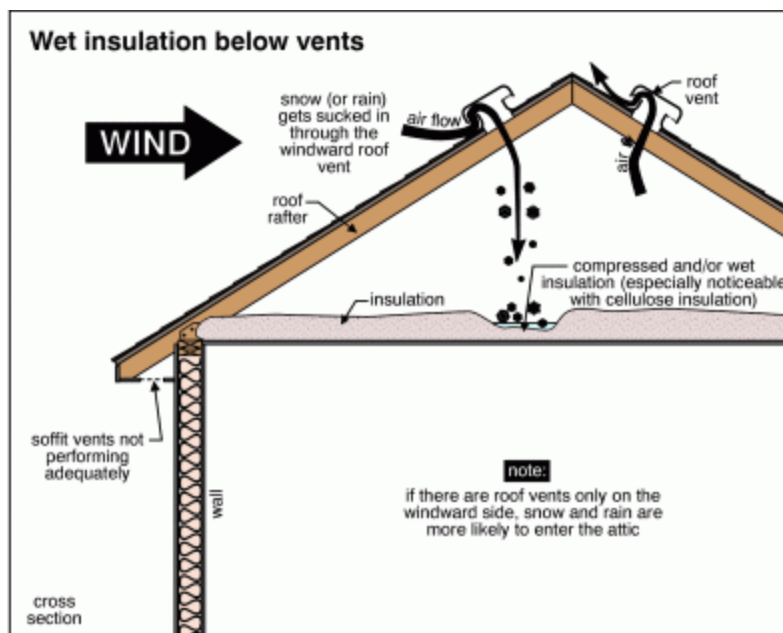
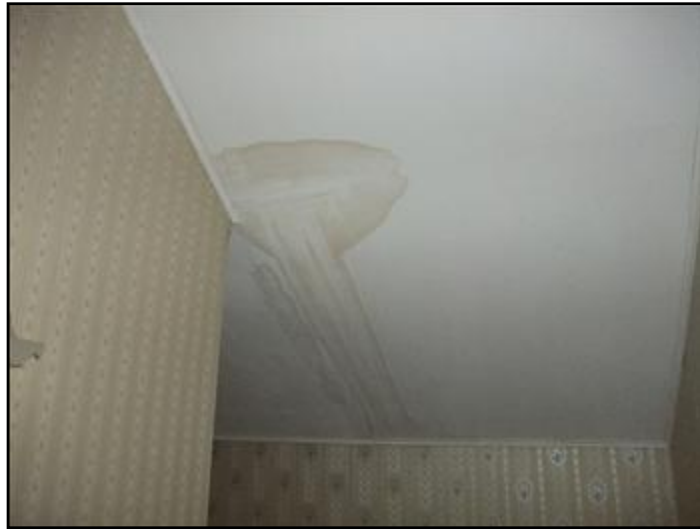
Condition: • [Snow or wet spots below roof vents](#)

Although not verified due to inaccessibility of the roof spaces and attic, it is possible that the stain in the accompanying photo is a result of snow or wind-driven rain entering via the roof vent(s.)

Task: Further evaluation

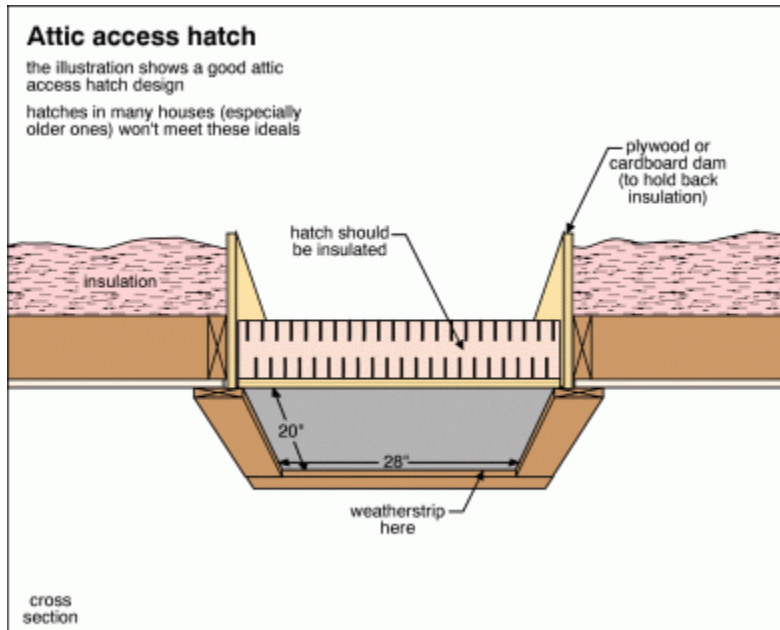
Condition: • [Missing](#)

No access provided to attics or roof spaces.

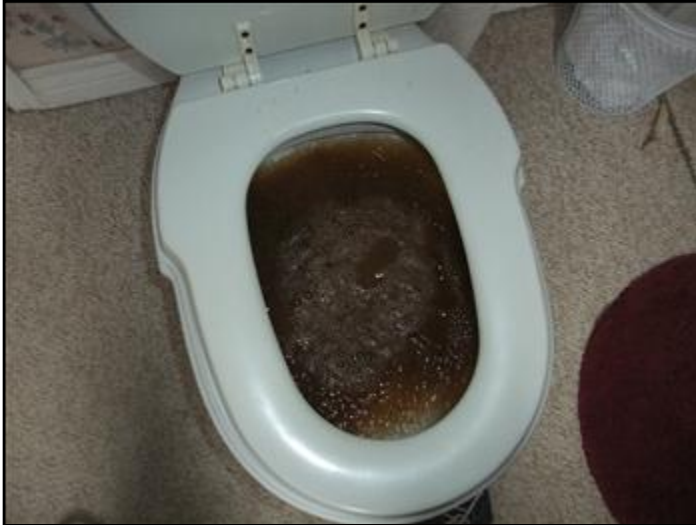
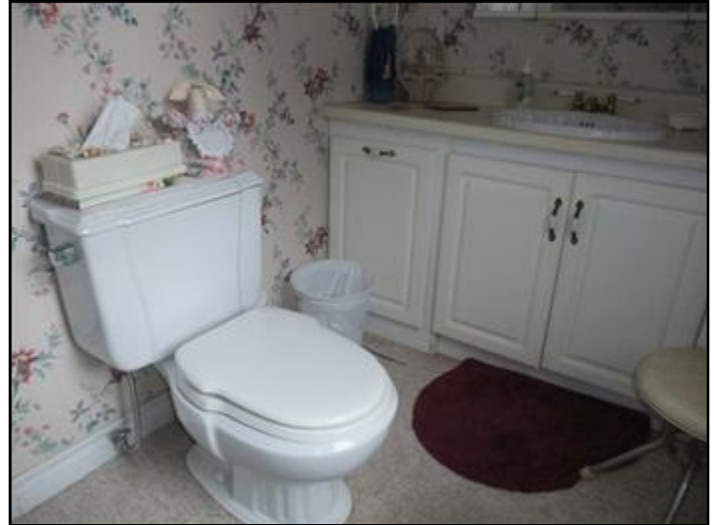
Condition: • Consult with a licensed plumber, if simple plunging does not free the toilet drain.

Implication(s): Toilet itself may be plugged, or another blockage may exist in the drain piping.

Task: Clean

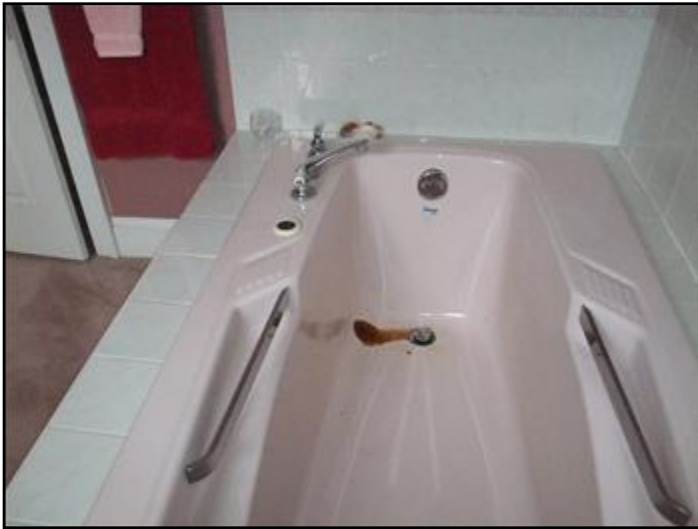
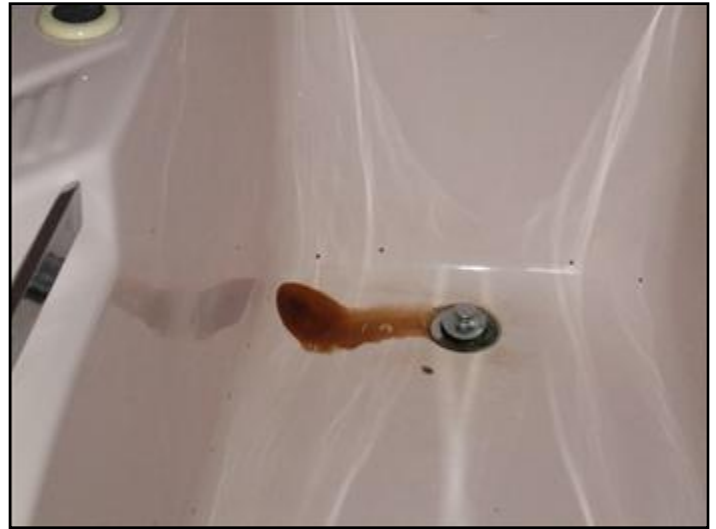
Condition: • [Rust](#)

It is not know whether this stain can be removed, nor what the cause is. The rust may be a result of disuse, rusting pipes (possibly galvanized steel, in inaccessible areas) or the quality of the municipal water.

Task: Further evaluation

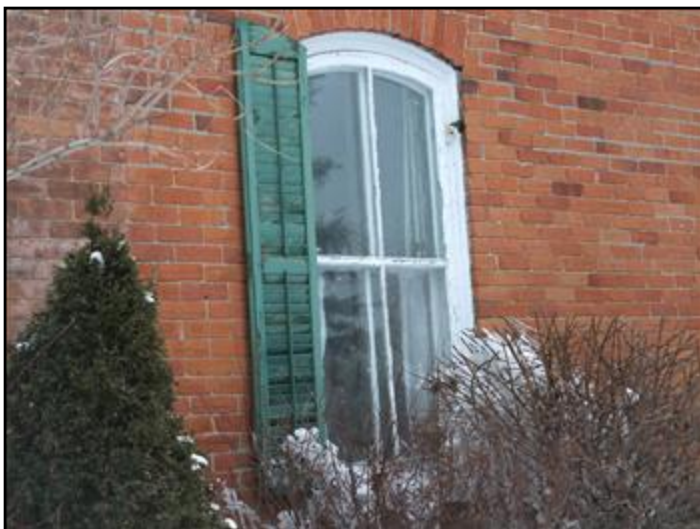
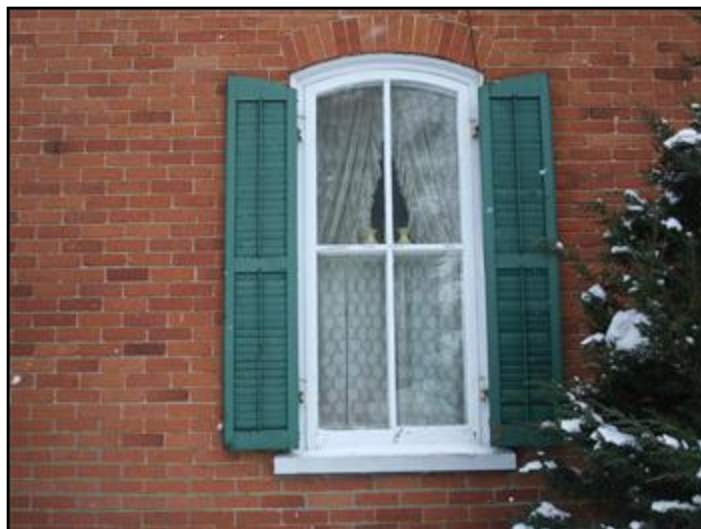
Condition: • [Original lower quality units](#)

Budget for eventual replacement of all remaining older, original windows; obtain two or more estimates for installed product.

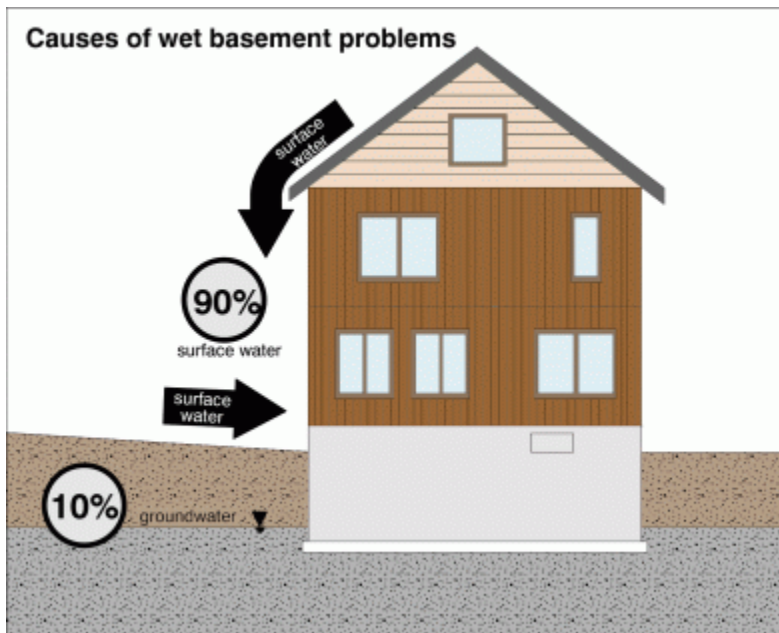
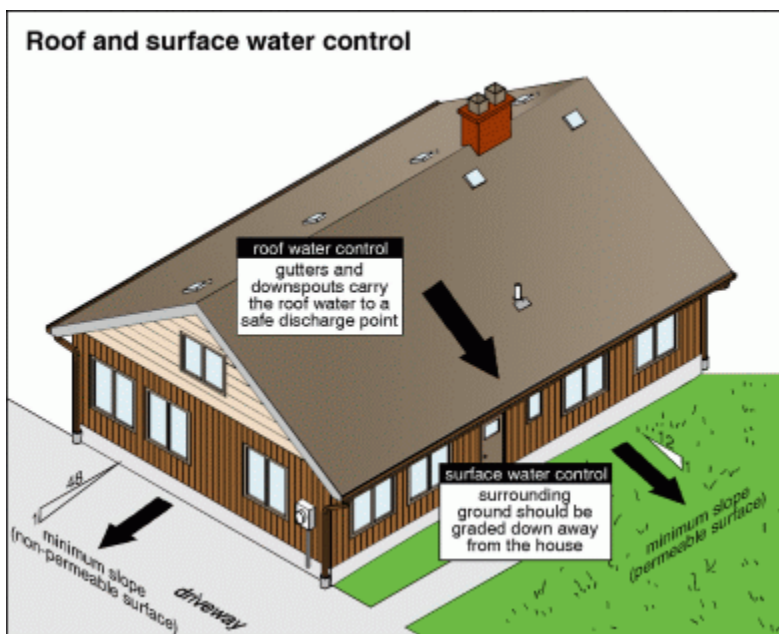
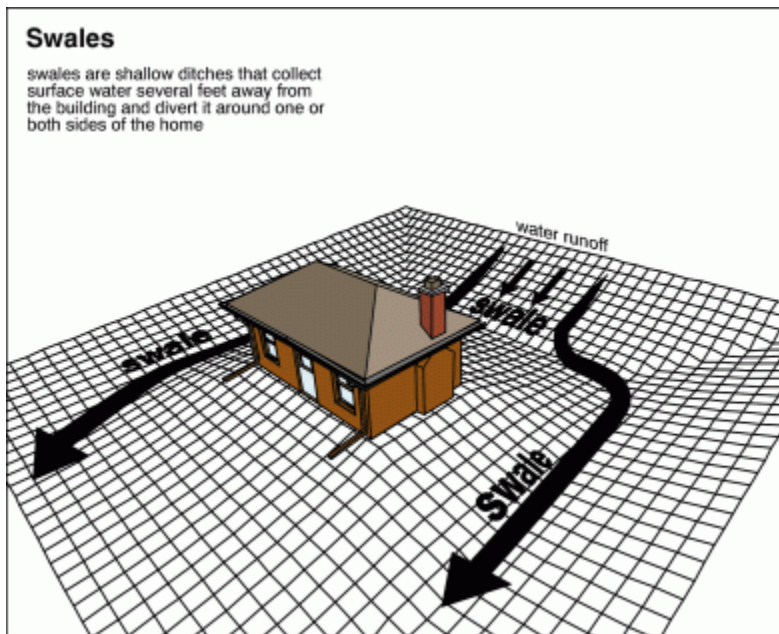
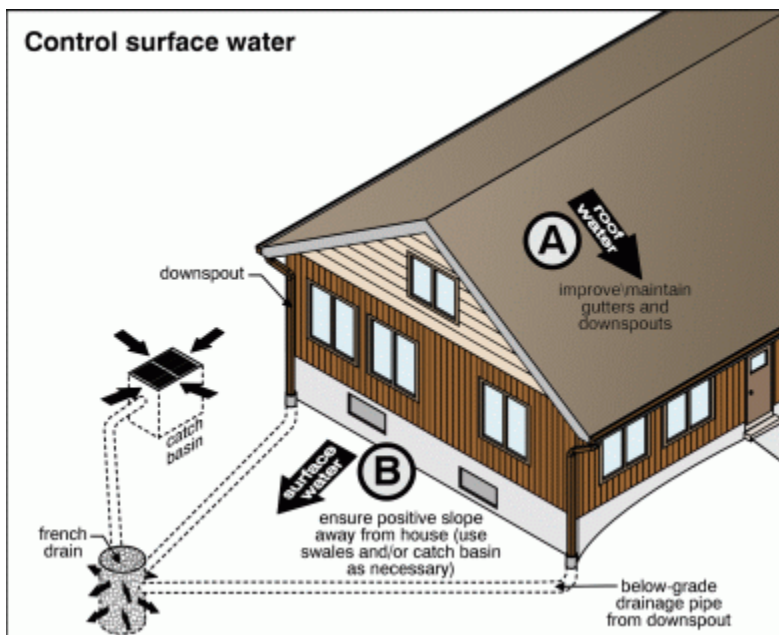
Condition: • [Poor grading](#)

Implication(s): Chance of water damage to contents, finishes and/or structure

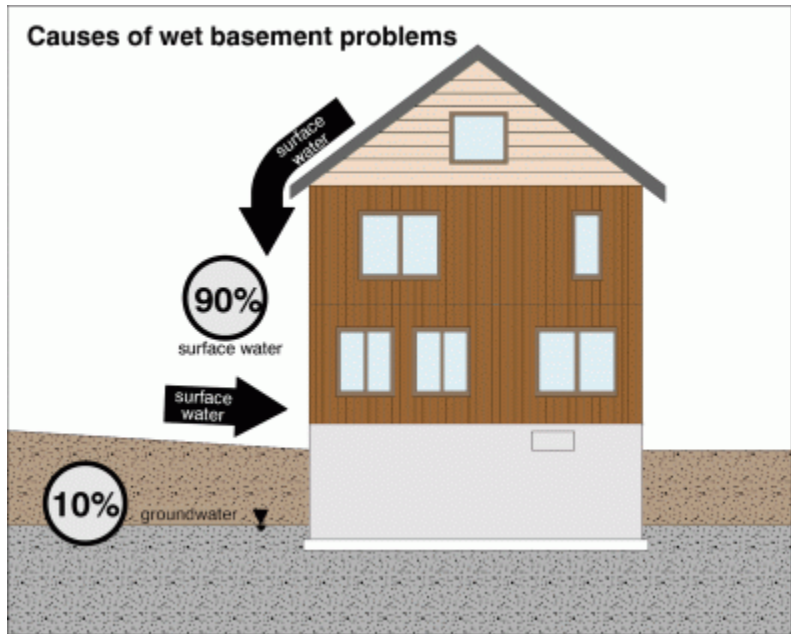
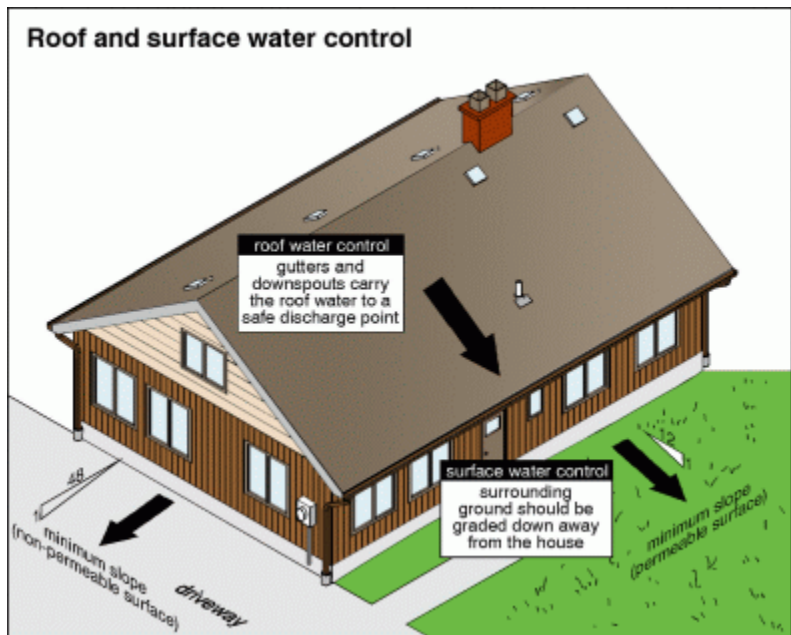
Condition: • [Poor gutters and downspouts](#)

Implication(s): Chance of water damage to contents, finishes and/or structure
