INSPECTION REPORT

1310 SYCAMORE
CHICAGO, IL

Inspection Date: Friday, July 31, 2009

XYZ Home Inspection Services
120 Carlton Street
Chicago, IL 12345
800-268-7070
416-964-0683

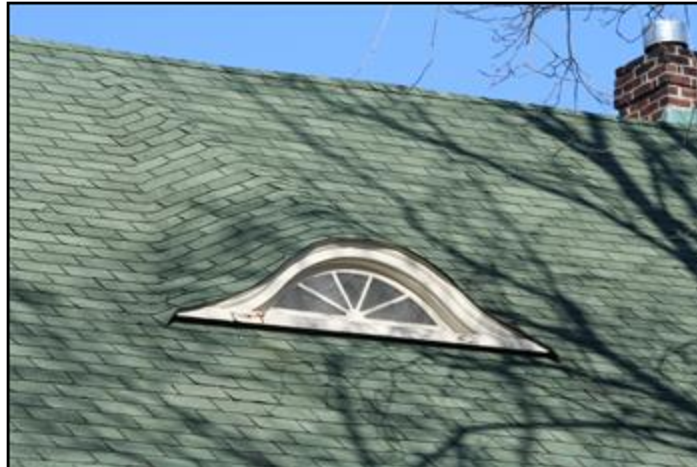
1. Asphalt roofing with decorative dormer

Probability of leakage: • Medium

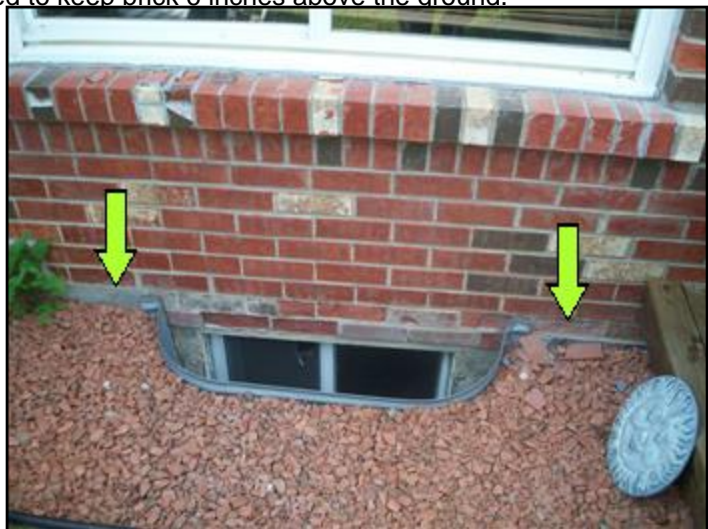
2.

Condition: • Too close to grade

Location: Right Side

Note: Grade should be lowered to keep brick 6 inches above the ground.

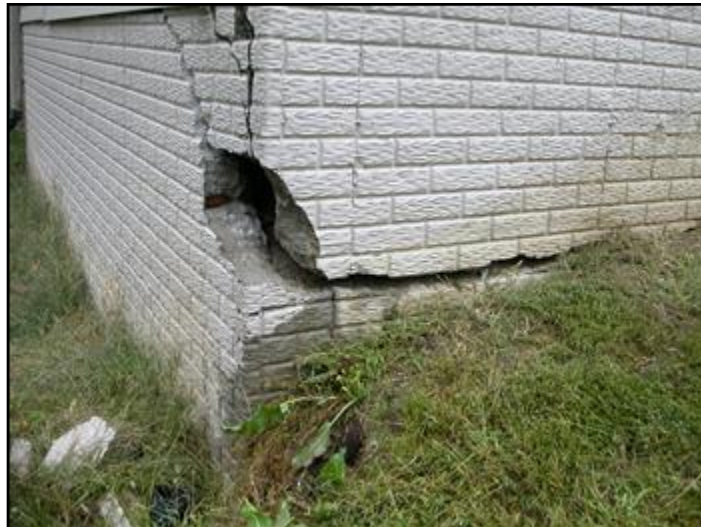
3.

Condition: • The foundation at the rear of the home has failed, apparently as a result of unstable soil on the sloped lot. A soils specialist should be engaged to determine whether the building can be stabilized.

Location: Rear

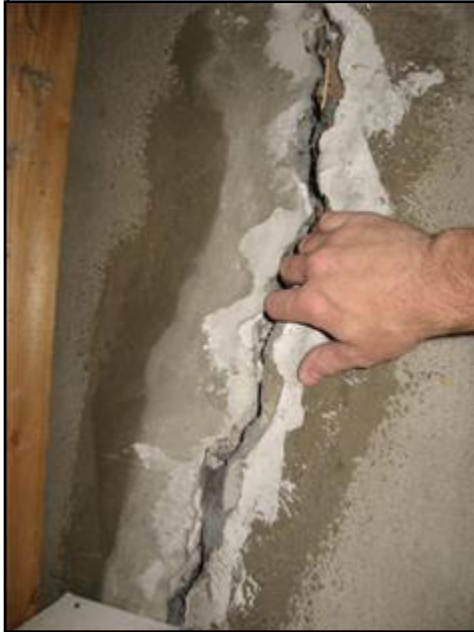
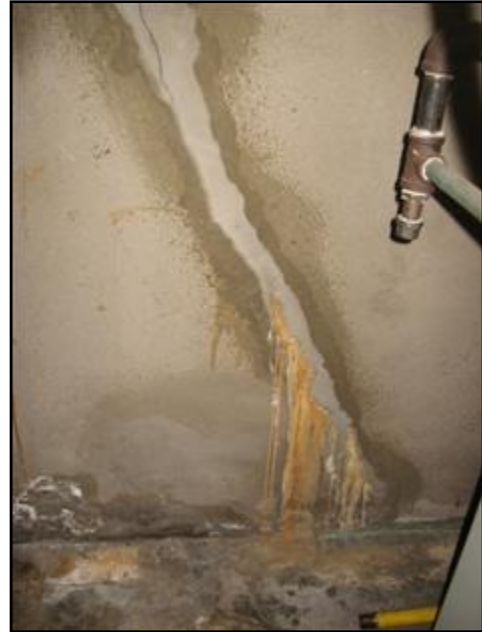
Condition: • Cracked

Location: Left Side Basement

Note: Severe cracking of the foundation wall was noted. It appears that movement is ongoing, since the crack has been patched at least once, and had reopened. The crack was leaking actively at the time of the inspection, although leakage is not the main concern. The building footing appears to be shifting, and needs to be stabilized. This is a high priority repair.

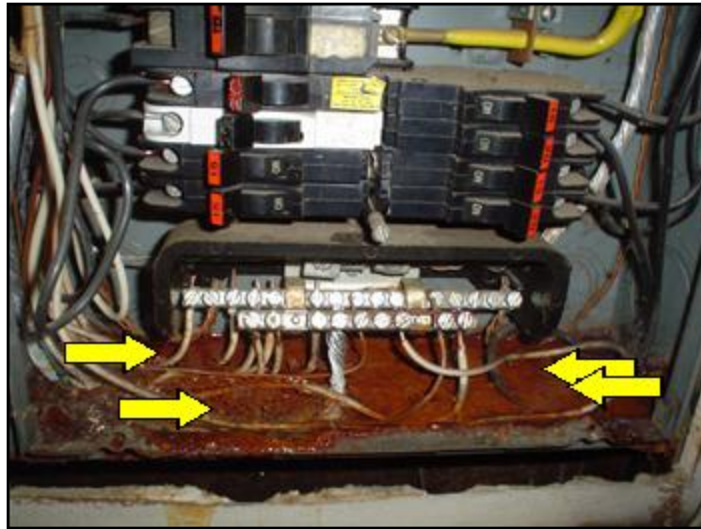
6.

Condition: • Rust or water in panel

Location: North Basement

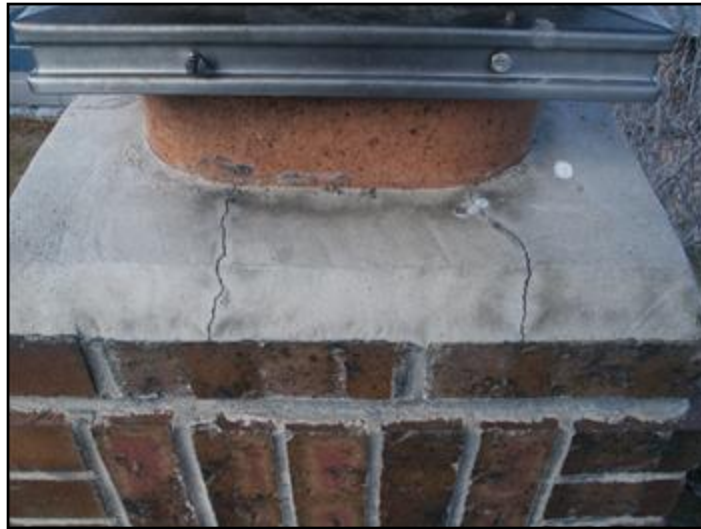
7.

General
• An annual maintenance agreement that covers parts and labor is recommended.
Gas furnace \ Life expectancy
Condition: • Old
Location: Basement
Task: Inspect annually
Chimney and vent \ Masonry chimney cap
Condition: • No drip edge on cap
Task: Improve
Time: If necessary

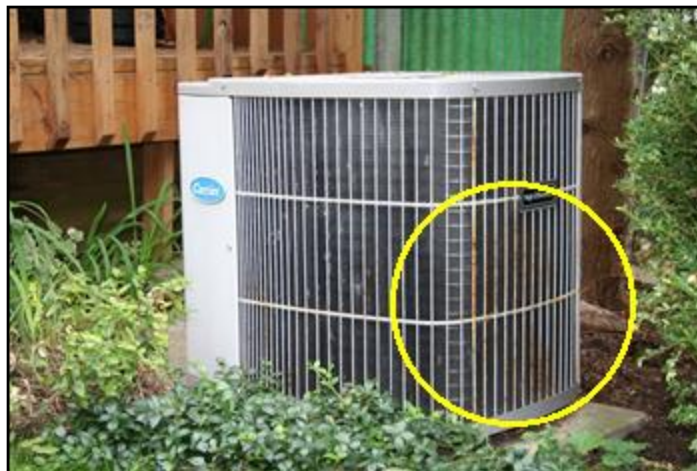
8.

Condition: • Corrosion

Location: Rear Exterior

Note: Rust on the air conditioner does not require immediate action, although this should be checked during annual servicing.

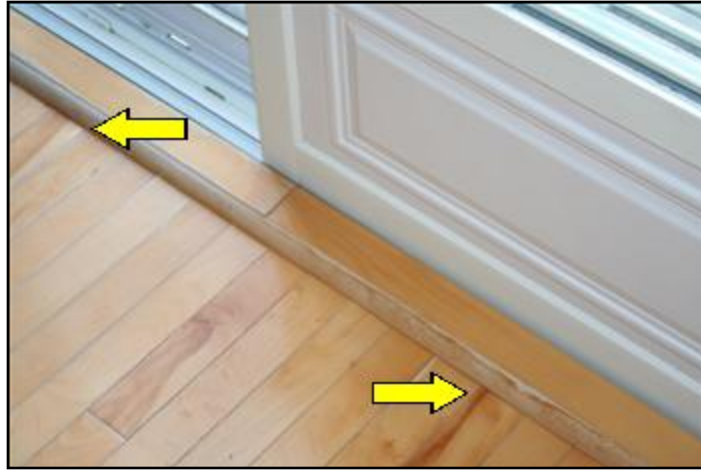
9.

Condition: • Stained

Location: Kitchen

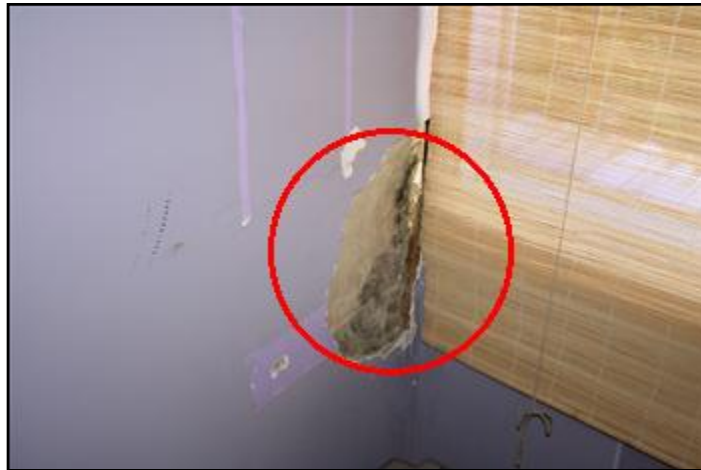
10.

Condition: • Water damage

Location: Rear Second Floor Bedroom

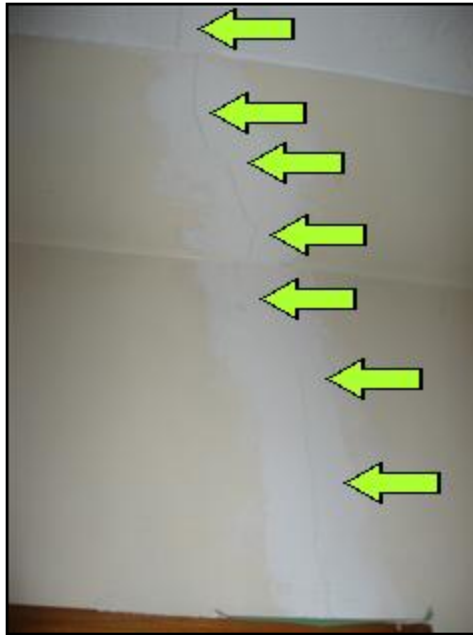
11.

Condition: • Cracked

Location: Northeast Dining Room
