Your Inspection Report

187 Panorama Dr.
Oakbrook, IL

INSPECTION DATE:
Sunday, December 13, 2009

Report No. 19942, v.2

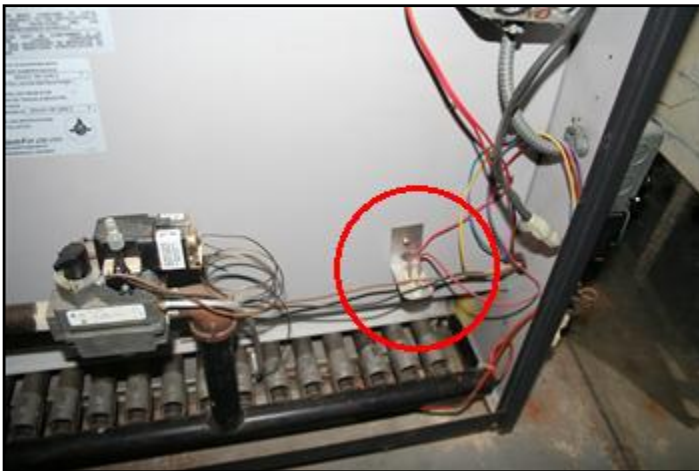
The flame rollout switch and spillage switch at the vent connector appeared to be in good order.

1. Flame rollout switch

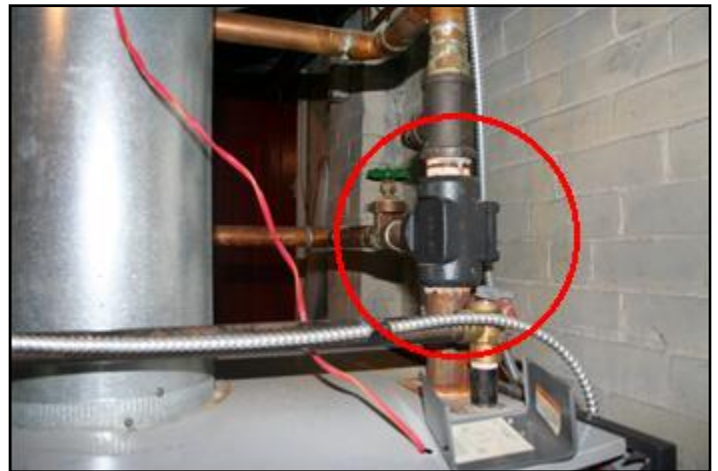
There is a thermostatically controlled bypass valve on the loop as well. Its installation and operation is suspect.

2. Thermostatic bypass valve

Further evaluate and improve the system bypass loop as needed.

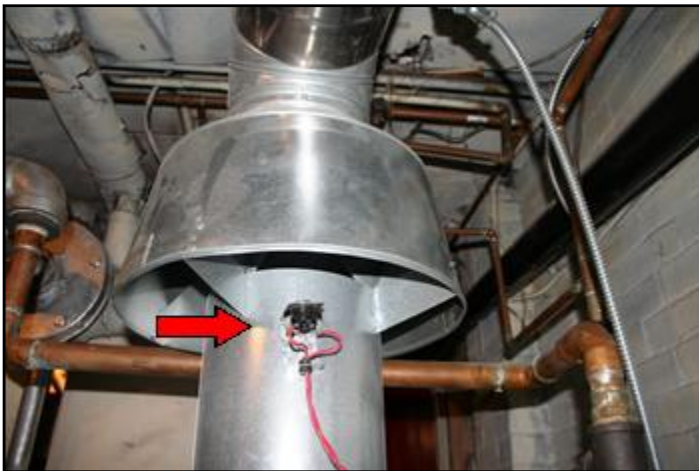
3. Draft spillage switch

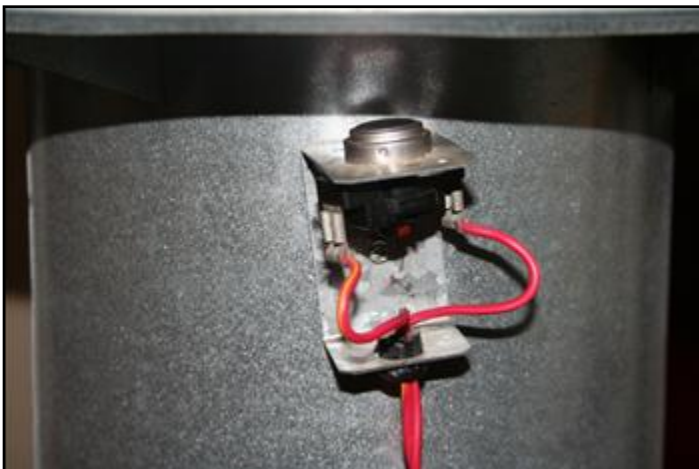
5. Draft spillage switch

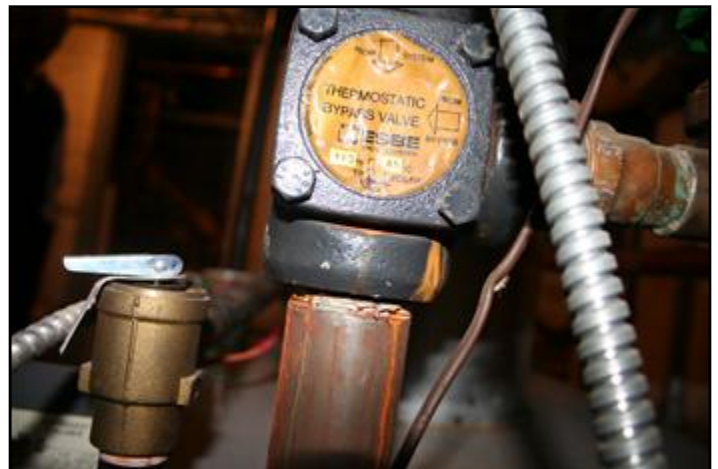
6. Thermostatic bypass valve

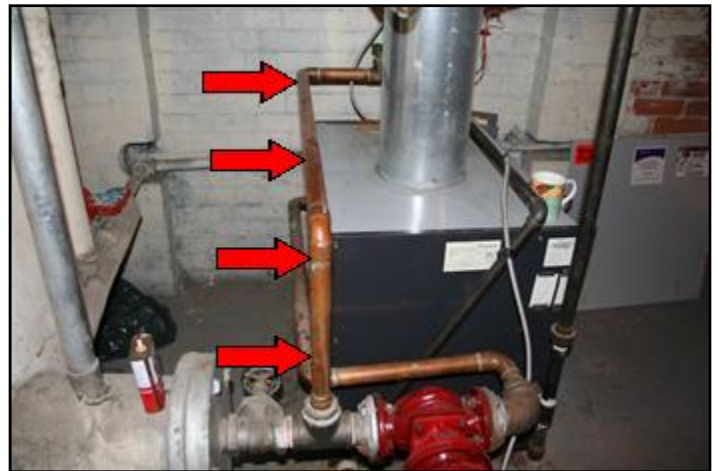
The one-inch system bypass loop was very hot. It is possible that the boiler is cycling on high-temperature limit because too much of the hot supply water is being redirected to the input side of the boiler.

8. Bypass loop

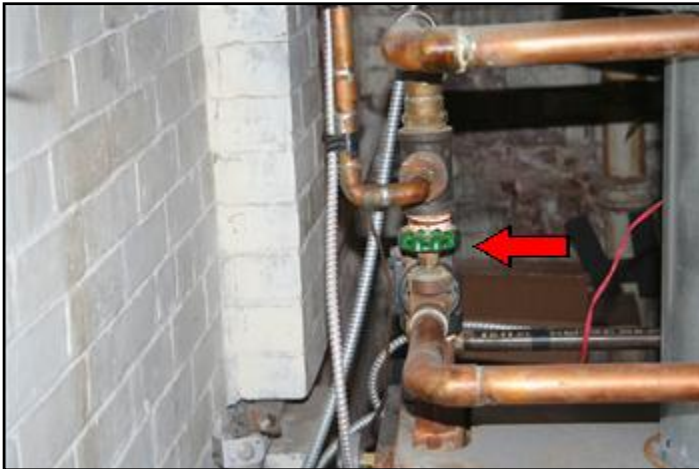
There is a manual valve on the bypass loop. The operation of this valve is suspect.

9. Suspect manual valve on bypass loop

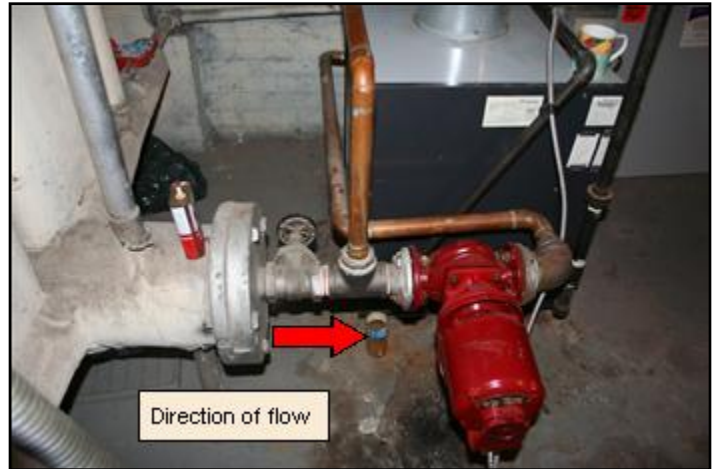
10. Bypass loop upstream of pump

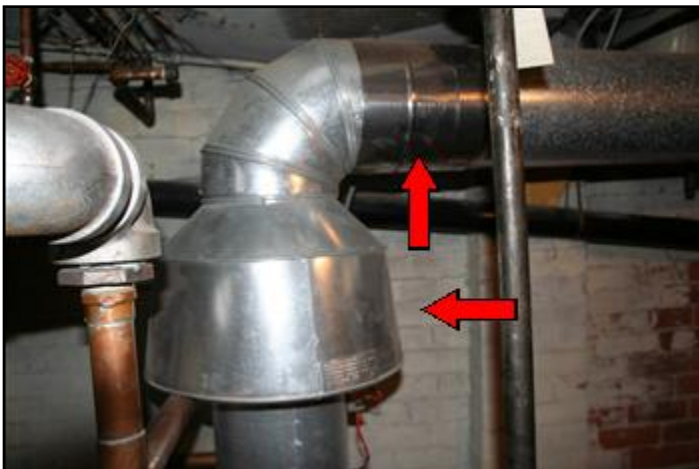
The automatic vent damper appeared to operate properly.

11. Draft hood - auto vent damper is above

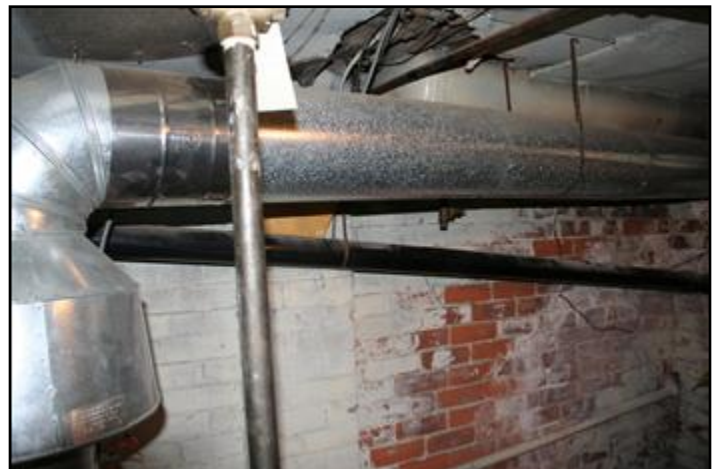
The vent connector slope is marginal. Solutions include moving the boiler closer to the chimney and replacing the expansion tank so that the connection to the chimney could be raised.

12. Marginal vent connector slope

Move the boiler closer to the chimney to improve the slope of the vent connector and improve the access to the temperature and pressure gauge.

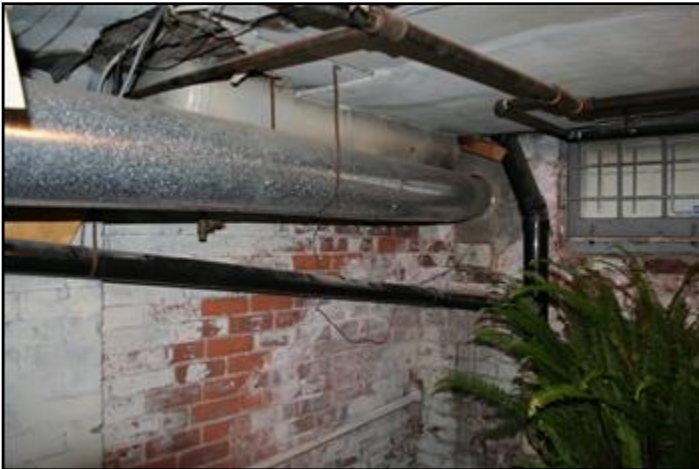
13. Marginal vent connector slope

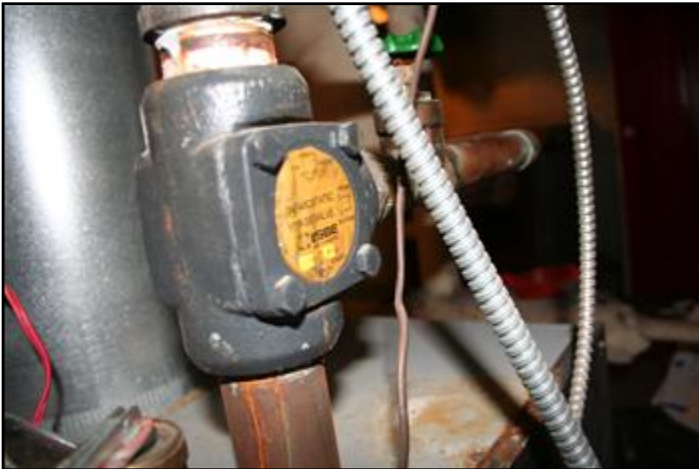
15. Thermostatic bypass valve

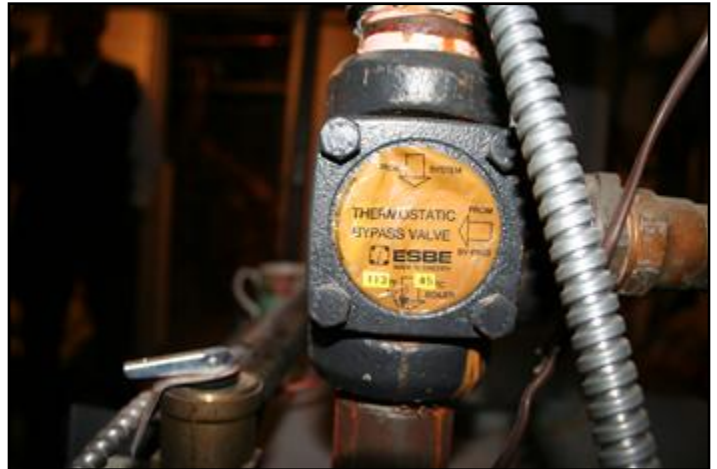
16. Thermostatic bypass valve

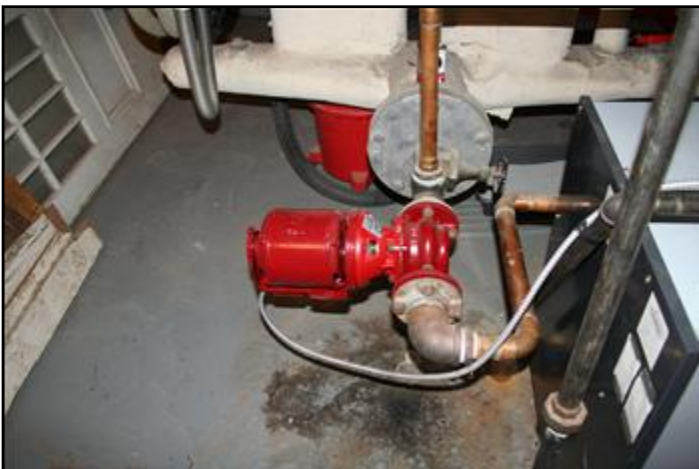
17. Circulator on return side

Relocate the circulating pump to pump away from the boiler.
