# Your Inspection Report

120 Rands Road  
Ajax, ON

**INSPECTION DATE:**  
Saturday, November 15, 2008

RE: Report No. 11831, v.3  
120 Rands Road  
Ajax, ON

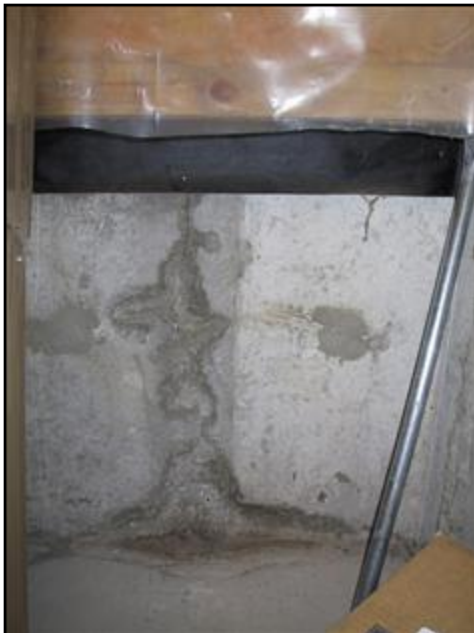
1. East wall

**Condition:** • [Foundation wall leaks](#)

Both cracks were wet to the touch.

**Location:** East Basement

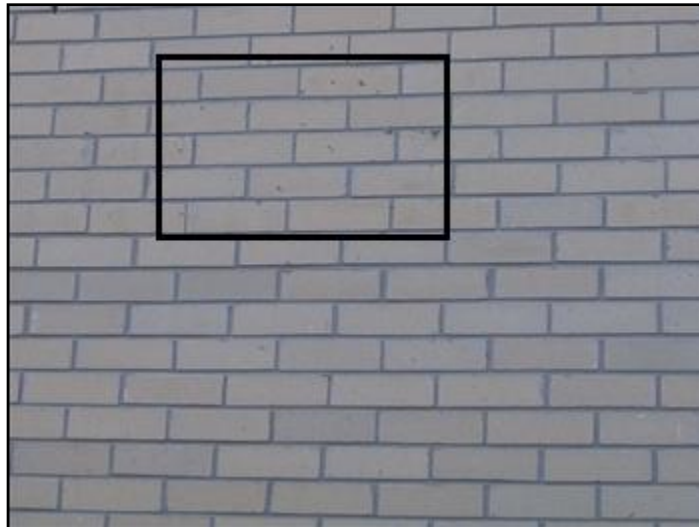
**Condition:** • [Mortar splatters and stains on exterior masonry](#)

**Location:** Right Side

3. Mortar splatters

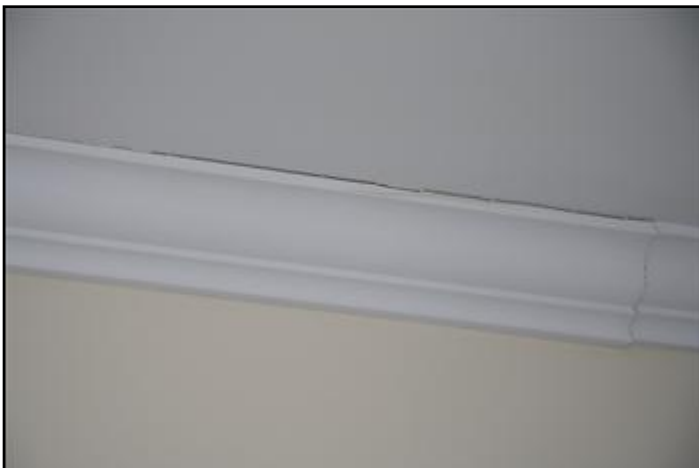
**Condition:** • [Interior trim is split](#)

**Location:** Living Room

4. Living room crown moulding - east wall

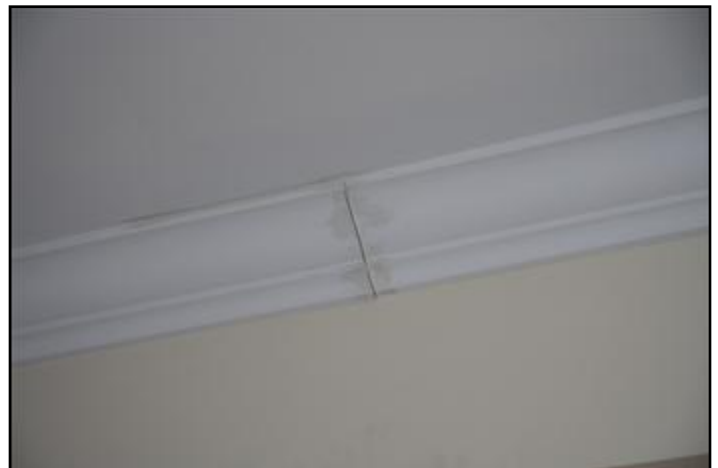
5. Living room crown moulding - west wall

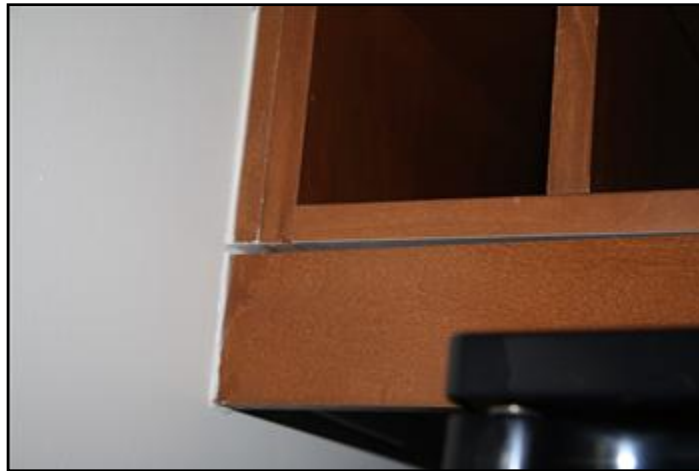
**Condition:** • [Gap between cabinets and ceilings or walls](#)

**Location:** Kitchen

6. Upper cabinet trim

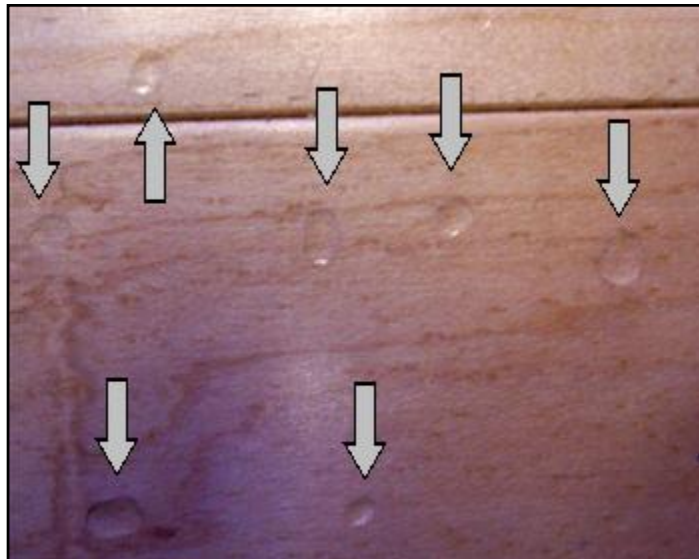
**Condition:** • Numerous dents in wood flooring

**Location:** Second Floor Hall

7. Floor near washroom
