Your Inspection Report

57 Hampton Ave.
Chicago, IL

RE: Report No. 19443, v.2
57 Hampton Ave.
Chicago, IL

Pre-Purchase Home Inspection

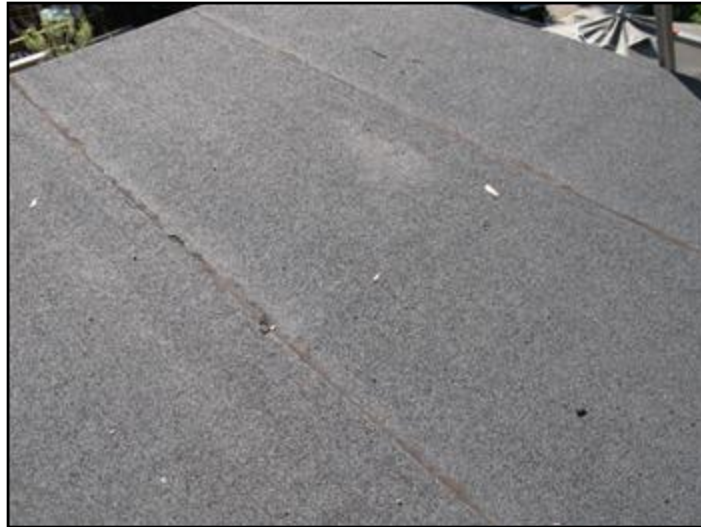
2. Flat roof at rear is in good repair

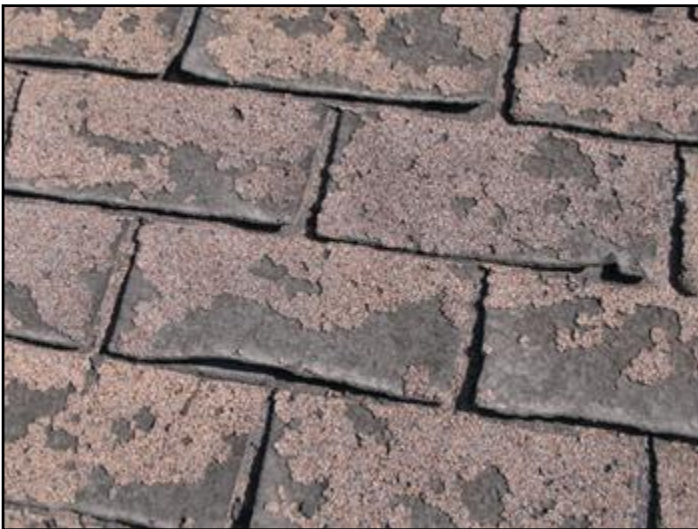
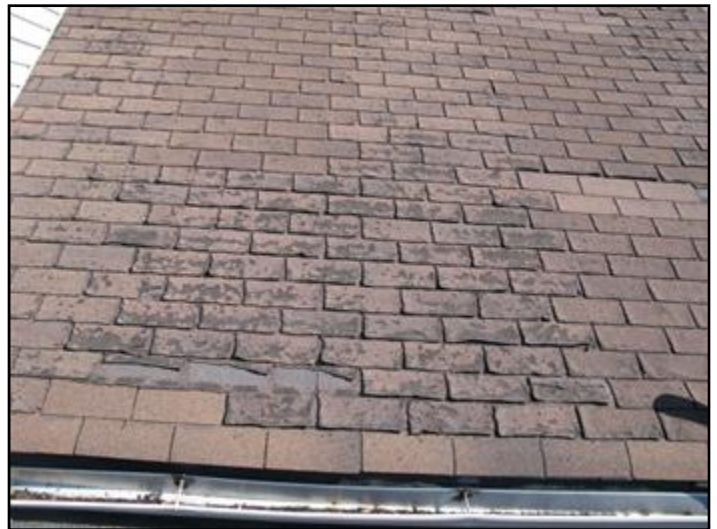
Condition: • [Old, worn out](#)

Location: Throughout

3. Closeup of worn out shingles

4. Worn out shingles

Task: Replace

Time: Immediate

Cost: \$3,000 - \$6,000

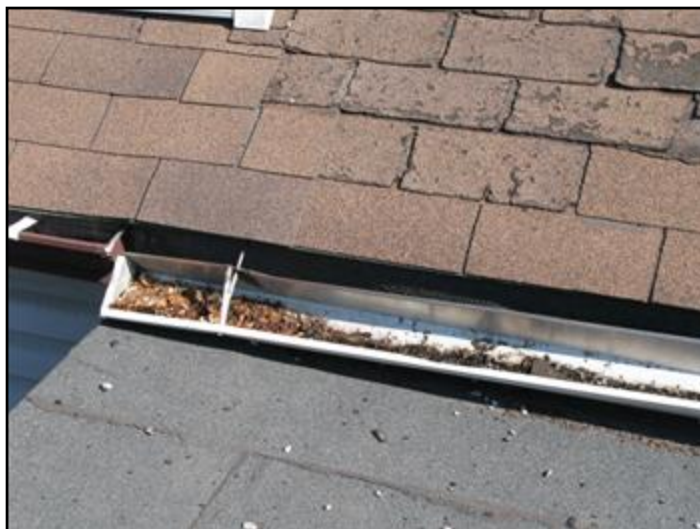
Condition: • [Loose or damaged](#)

Location: Rear

5. Loose gutter

Task: Improve

Time: Less than 1 year

Cost: Minor

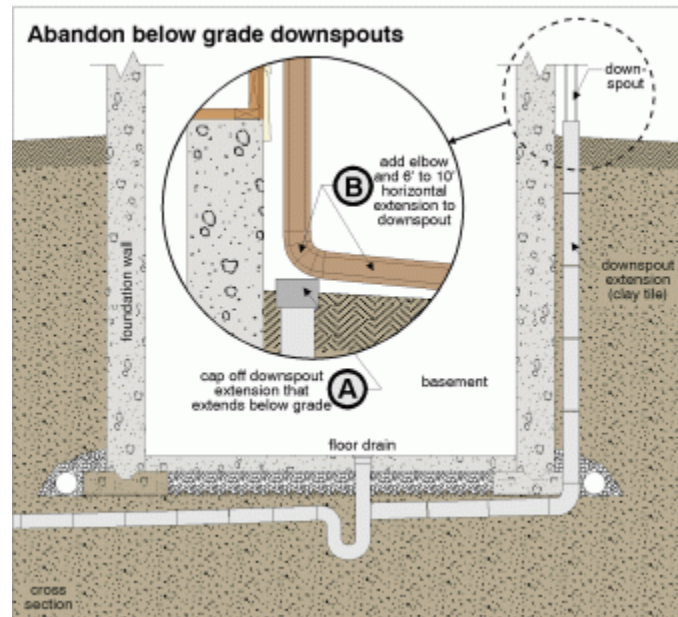
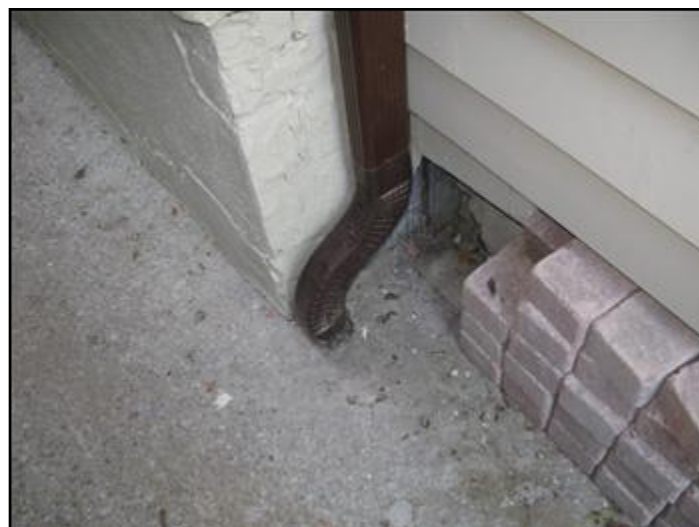
Condition: • [Downspouts discharging below grade](#)

Downspouts should discharge above grade at least six feet away from the foundation wall to avoid basement leakage.

Location: Northeast

6. Downspout going below the ground

Task: Discharge away from home

Time: Less than 1 year

Cost: Minor

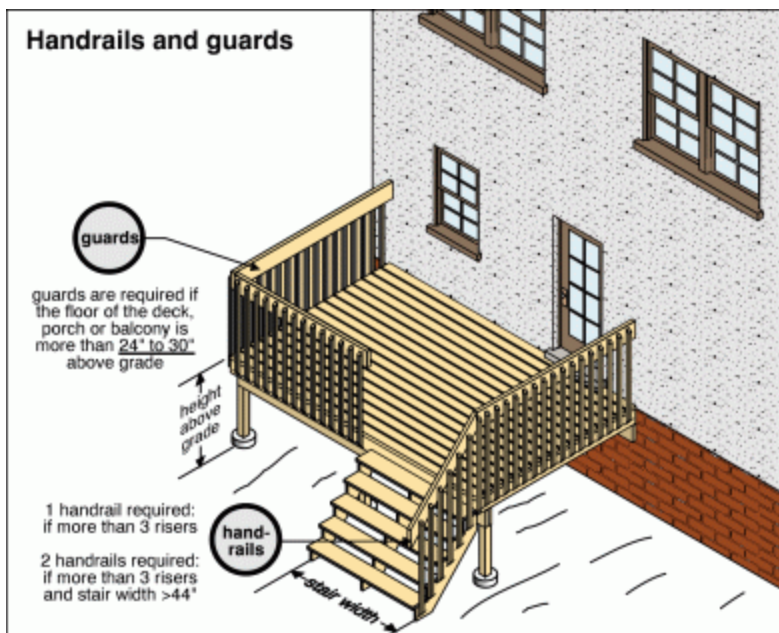
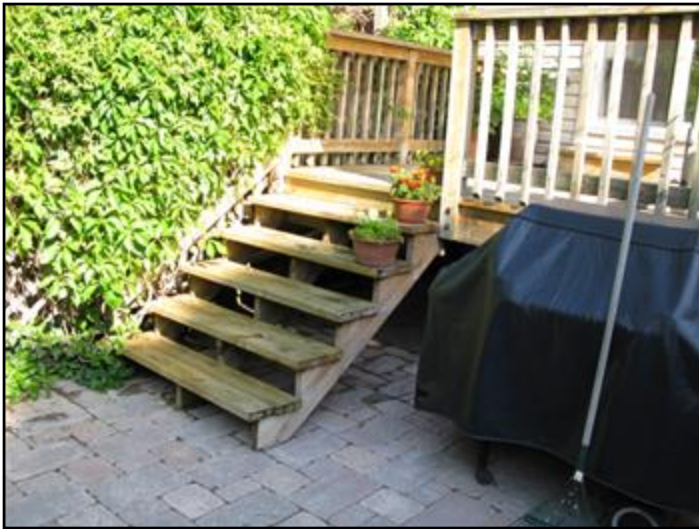
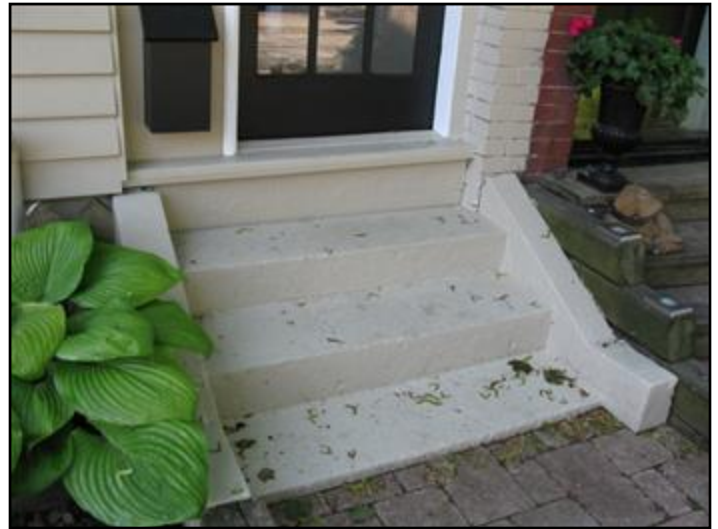
Condition: • [Missing](#)

Location: Front, Rear

7. Handrail covered by vegetation

8. Front steps - no handrail

Task: Provide

Time: Less than 1 year

Cost: Depends on approach

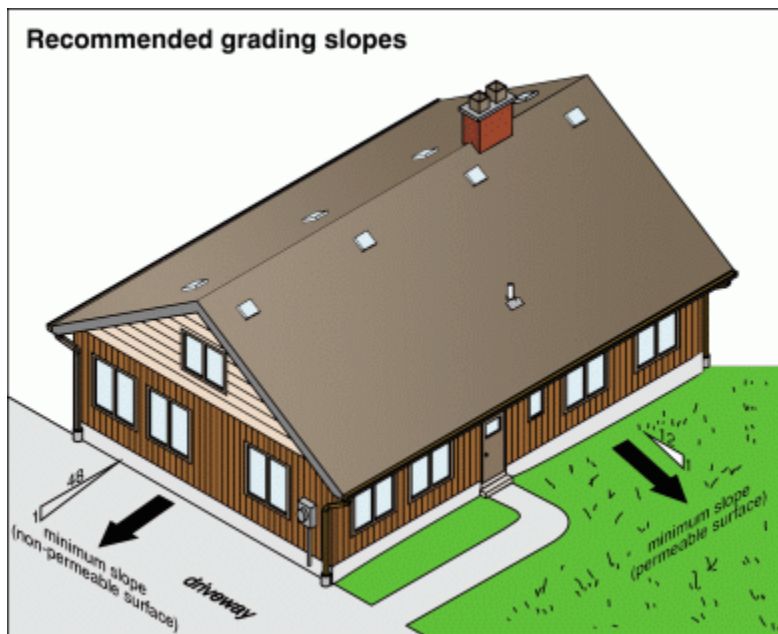
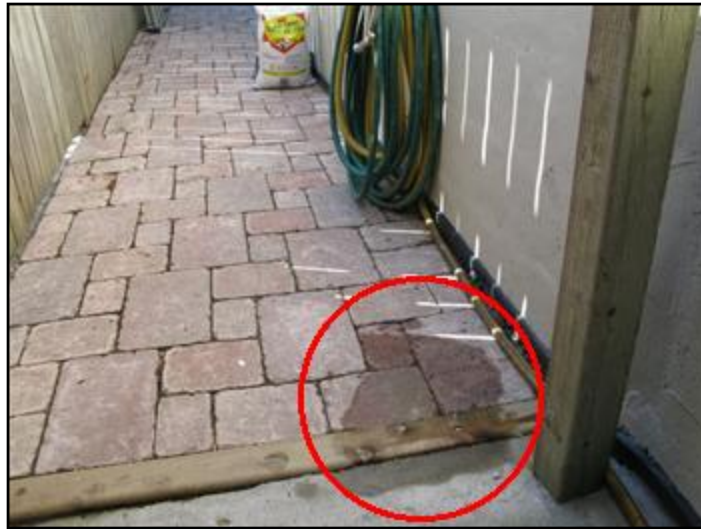
Condition: • [Improper slope](#)

Location: Southeast

9. *Poor slope for drainage*

Task: Improve

Time: If necessary

Cost: Depends on approach

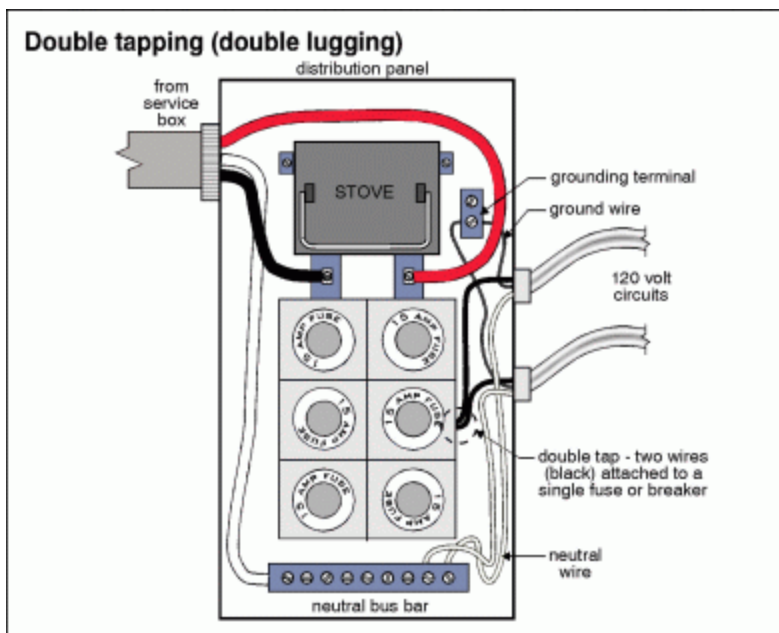
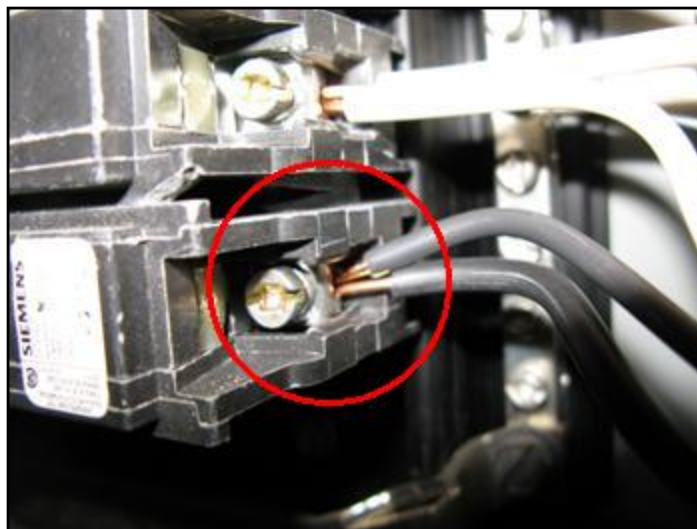
Condition: • [Double taps](#)

Location: Panel

11. Two wires on a single breaker

Task: Correct

Time: Immediate

Cost: Minor

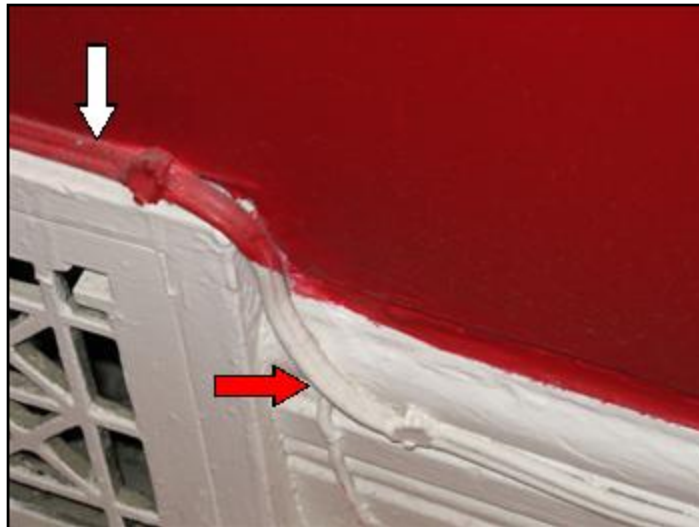
Condition: • [Exposed on walls or ceilings](#)

Location: Front Second Floor Bedroom

12. Surface-mounted wire

Task: Correct

Time: Immediate

Cost: Depends on approach

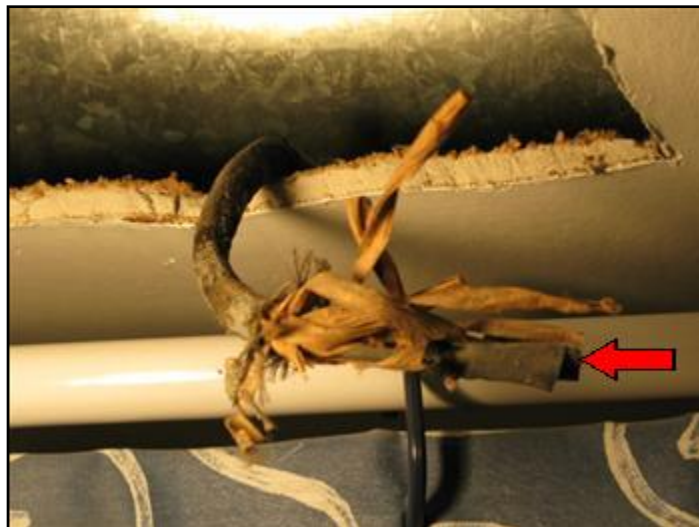
Condition: • [Abandoned wire](#)

Location: Center Basement

13. Apparently abandoned wire

Task: Further evaluation by specialist

Time: Immediate

Cost: Minor

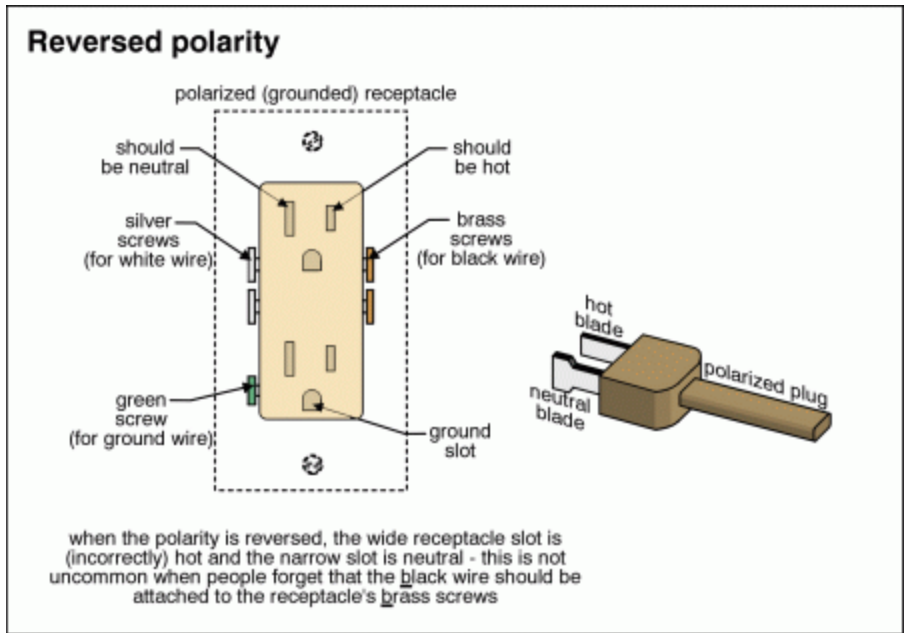
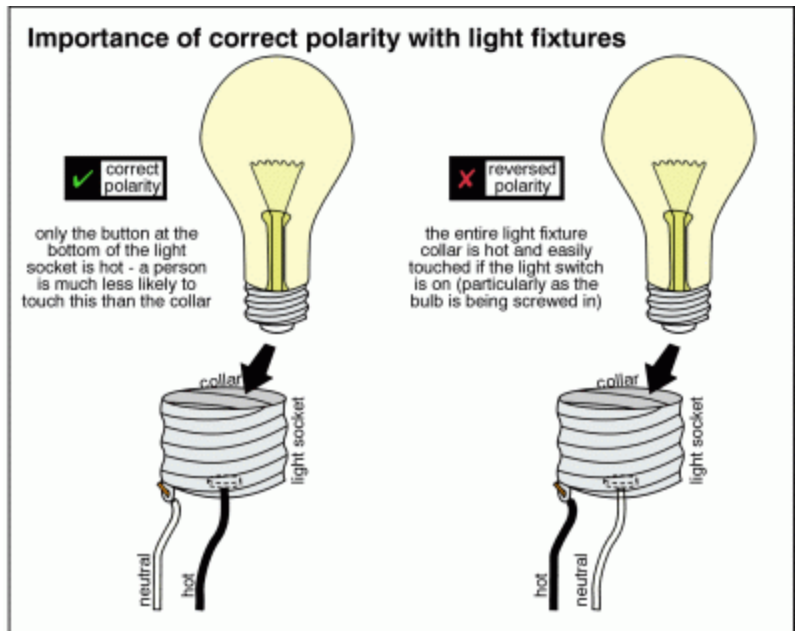
Condition: • [Reversed polarity](#)

Location: Front of Living Room, Basement Bathroom

Task: Correct

Time: Immediate

Cost: Minor

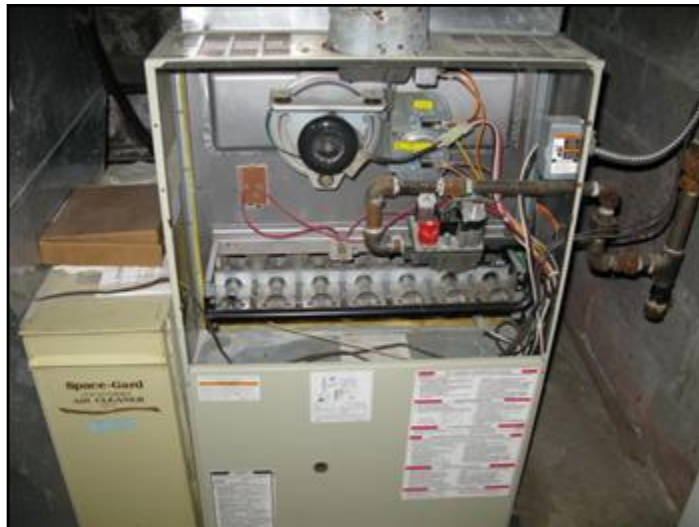
Approximate age: • [17 years](#)

Typical life expectancy: • Furnace (conventional or mid-efficiency) 18 to 25 years

Condition: • [Near end of life expectancy](#)

Location: Basement

14. Gas furnace

Task: Replace

Time: Unpredictable

Cost: \$4,000 - \$8,000

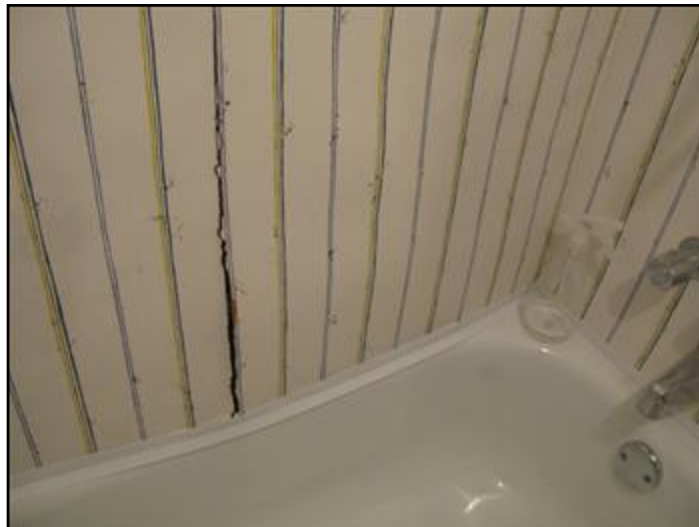
Condition: • Low quality. Risk of water leaks and potential for water damage.

Location: Basement Bathroom

16. Low-quality, wood tub enclosure

Task: Upgrade

Time: When remodelling

Cost: \$1,500 - and up

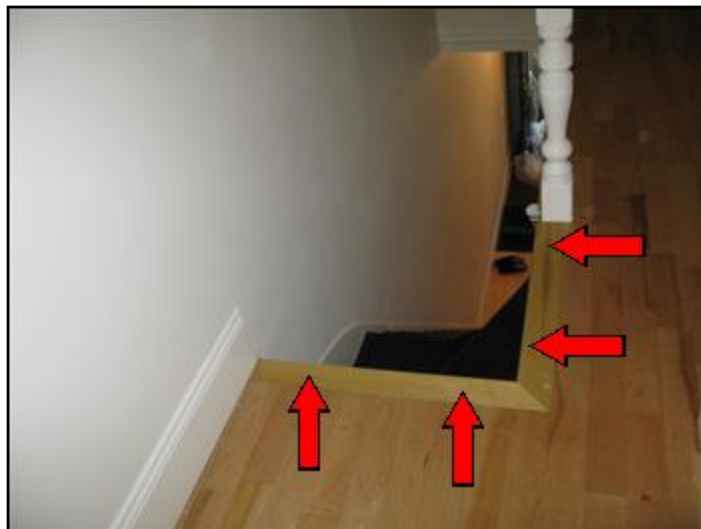
- Condition:** • [Missing](#)
- Guard (railing) does not extend all the way along the side of the stairwell opening.
- Location:** Second Floor
- Task:** Correct
- Time:** If necessary
- Cost:** Depends on approach

17. Top of stairs

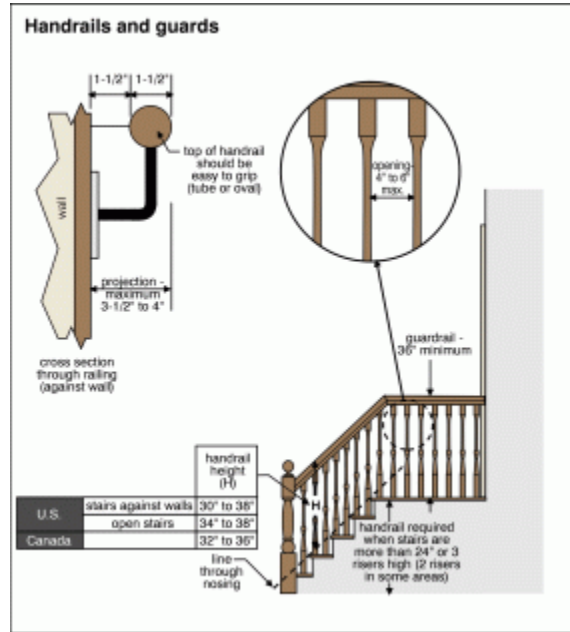
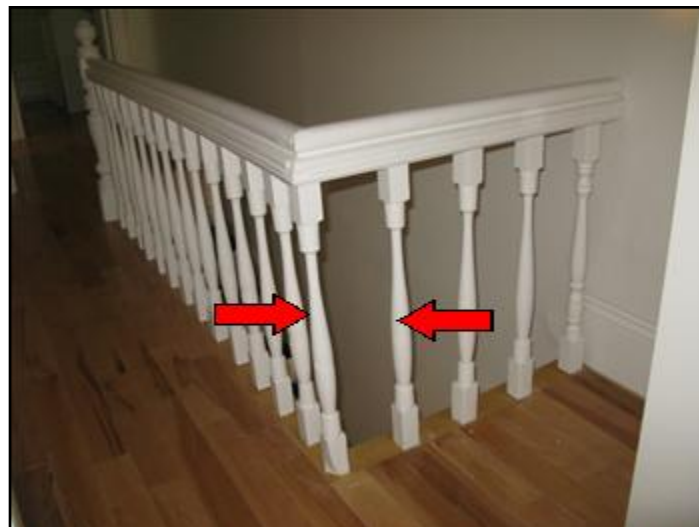
Condition: • [Too far apart](#)

The spacing may allow a small child to fall through.

Location: Second Floor

18. Wide spacing in railing

Task: Improve

Time: Discretionary

Cost: Depends on approach
