Your Inspection Report

27 Maple Crescent
Toronto, ON

RE: Report No. 1366, v.7
27 Maple Crescent
Toronto, ON

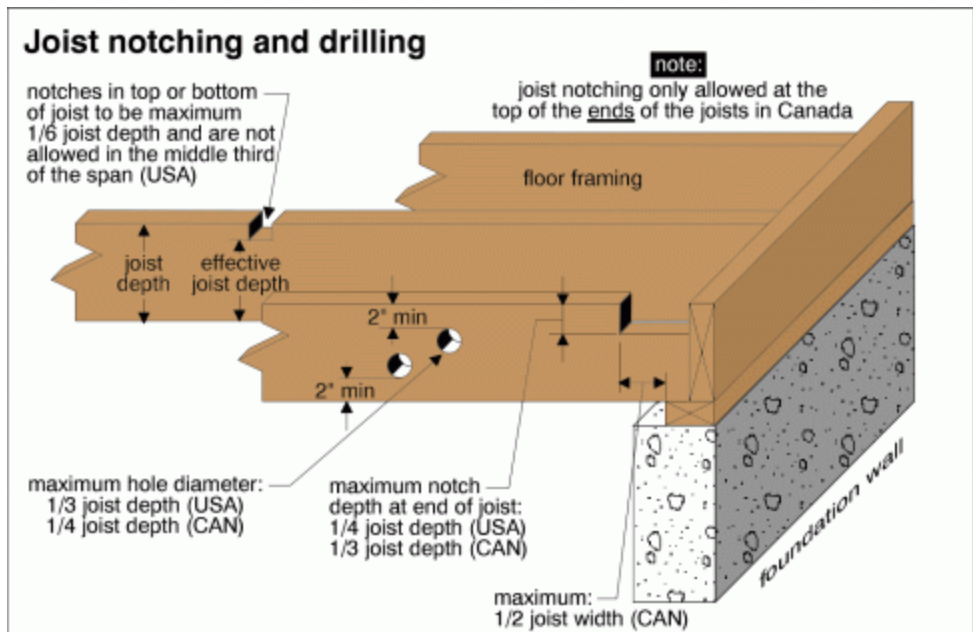
- Condition:** • [Notches or holes](#)
- Implication(s):** Weakened structure
- Location:** West Basement
- Task:** Repair
- Time:** Immediate

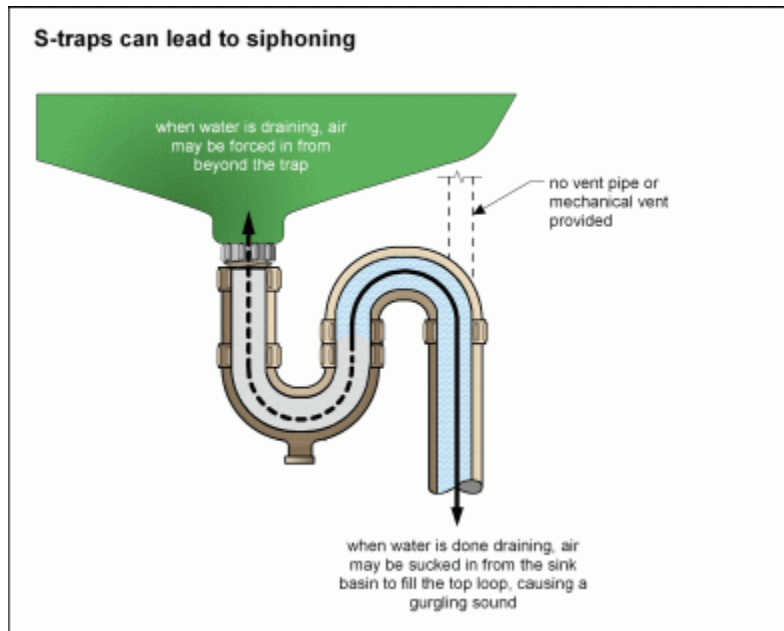
Note: This configuration is prone to clogging problems

Time: Less than 1 year
